Potential Spawning
Tributaries
for

The South Fork Boise River

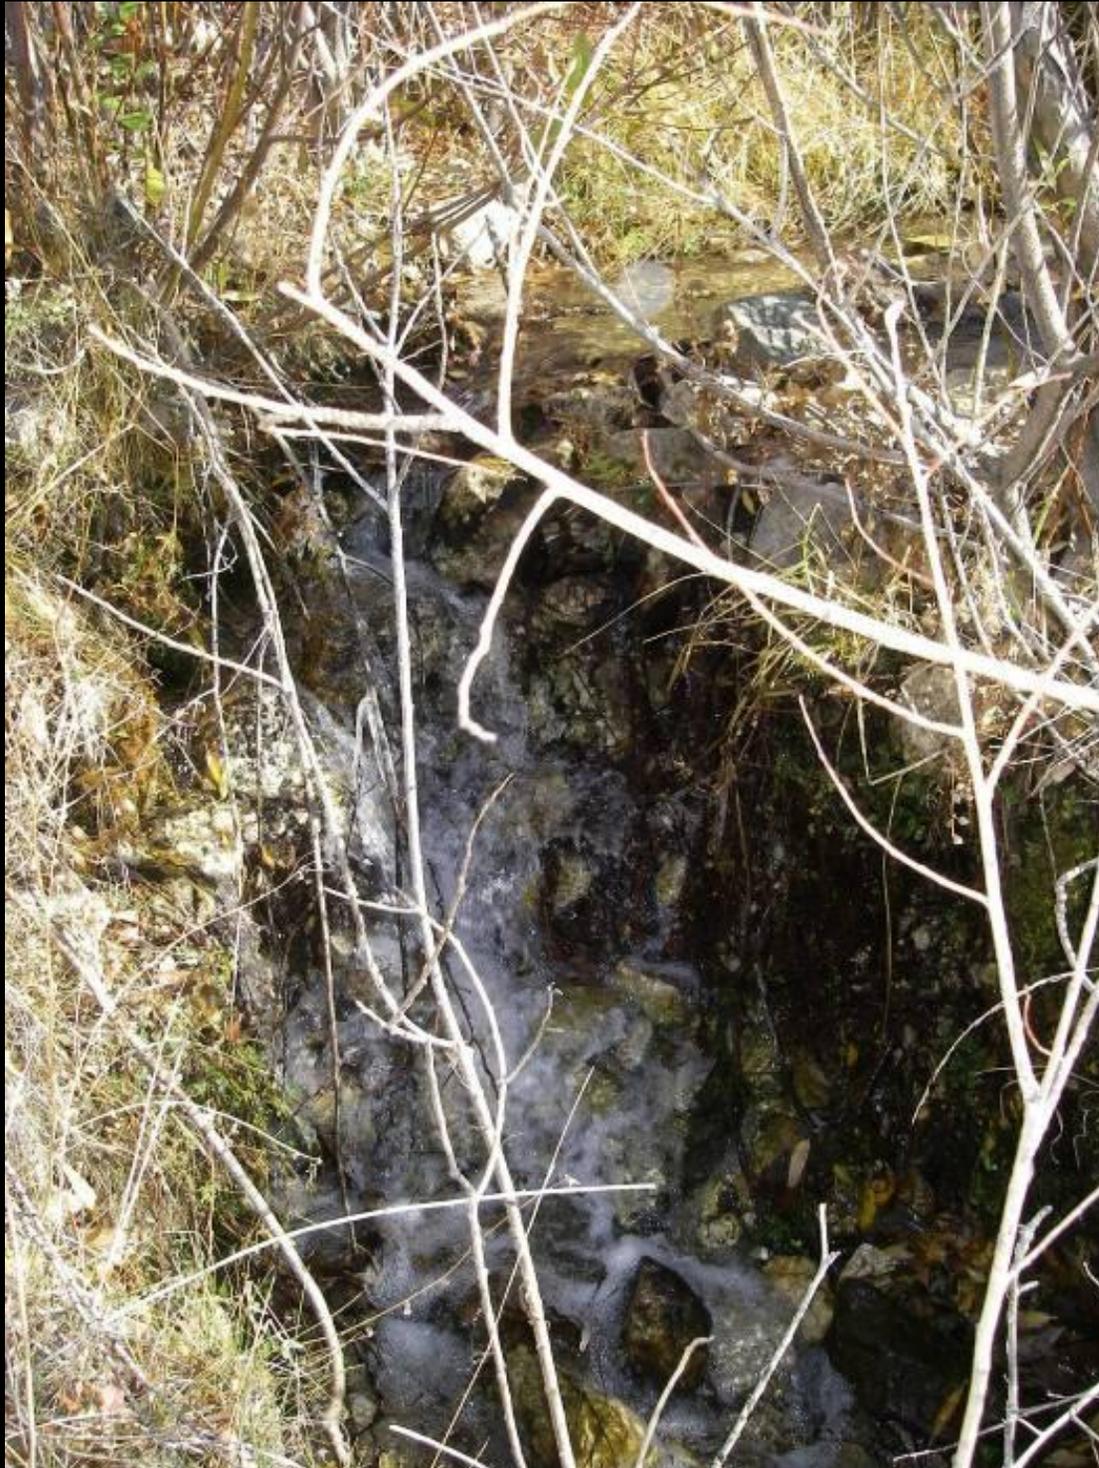
Rough Creek at Slide Rapid
(below Indian Rock)

3-4 foot high cascade
due to flood debris

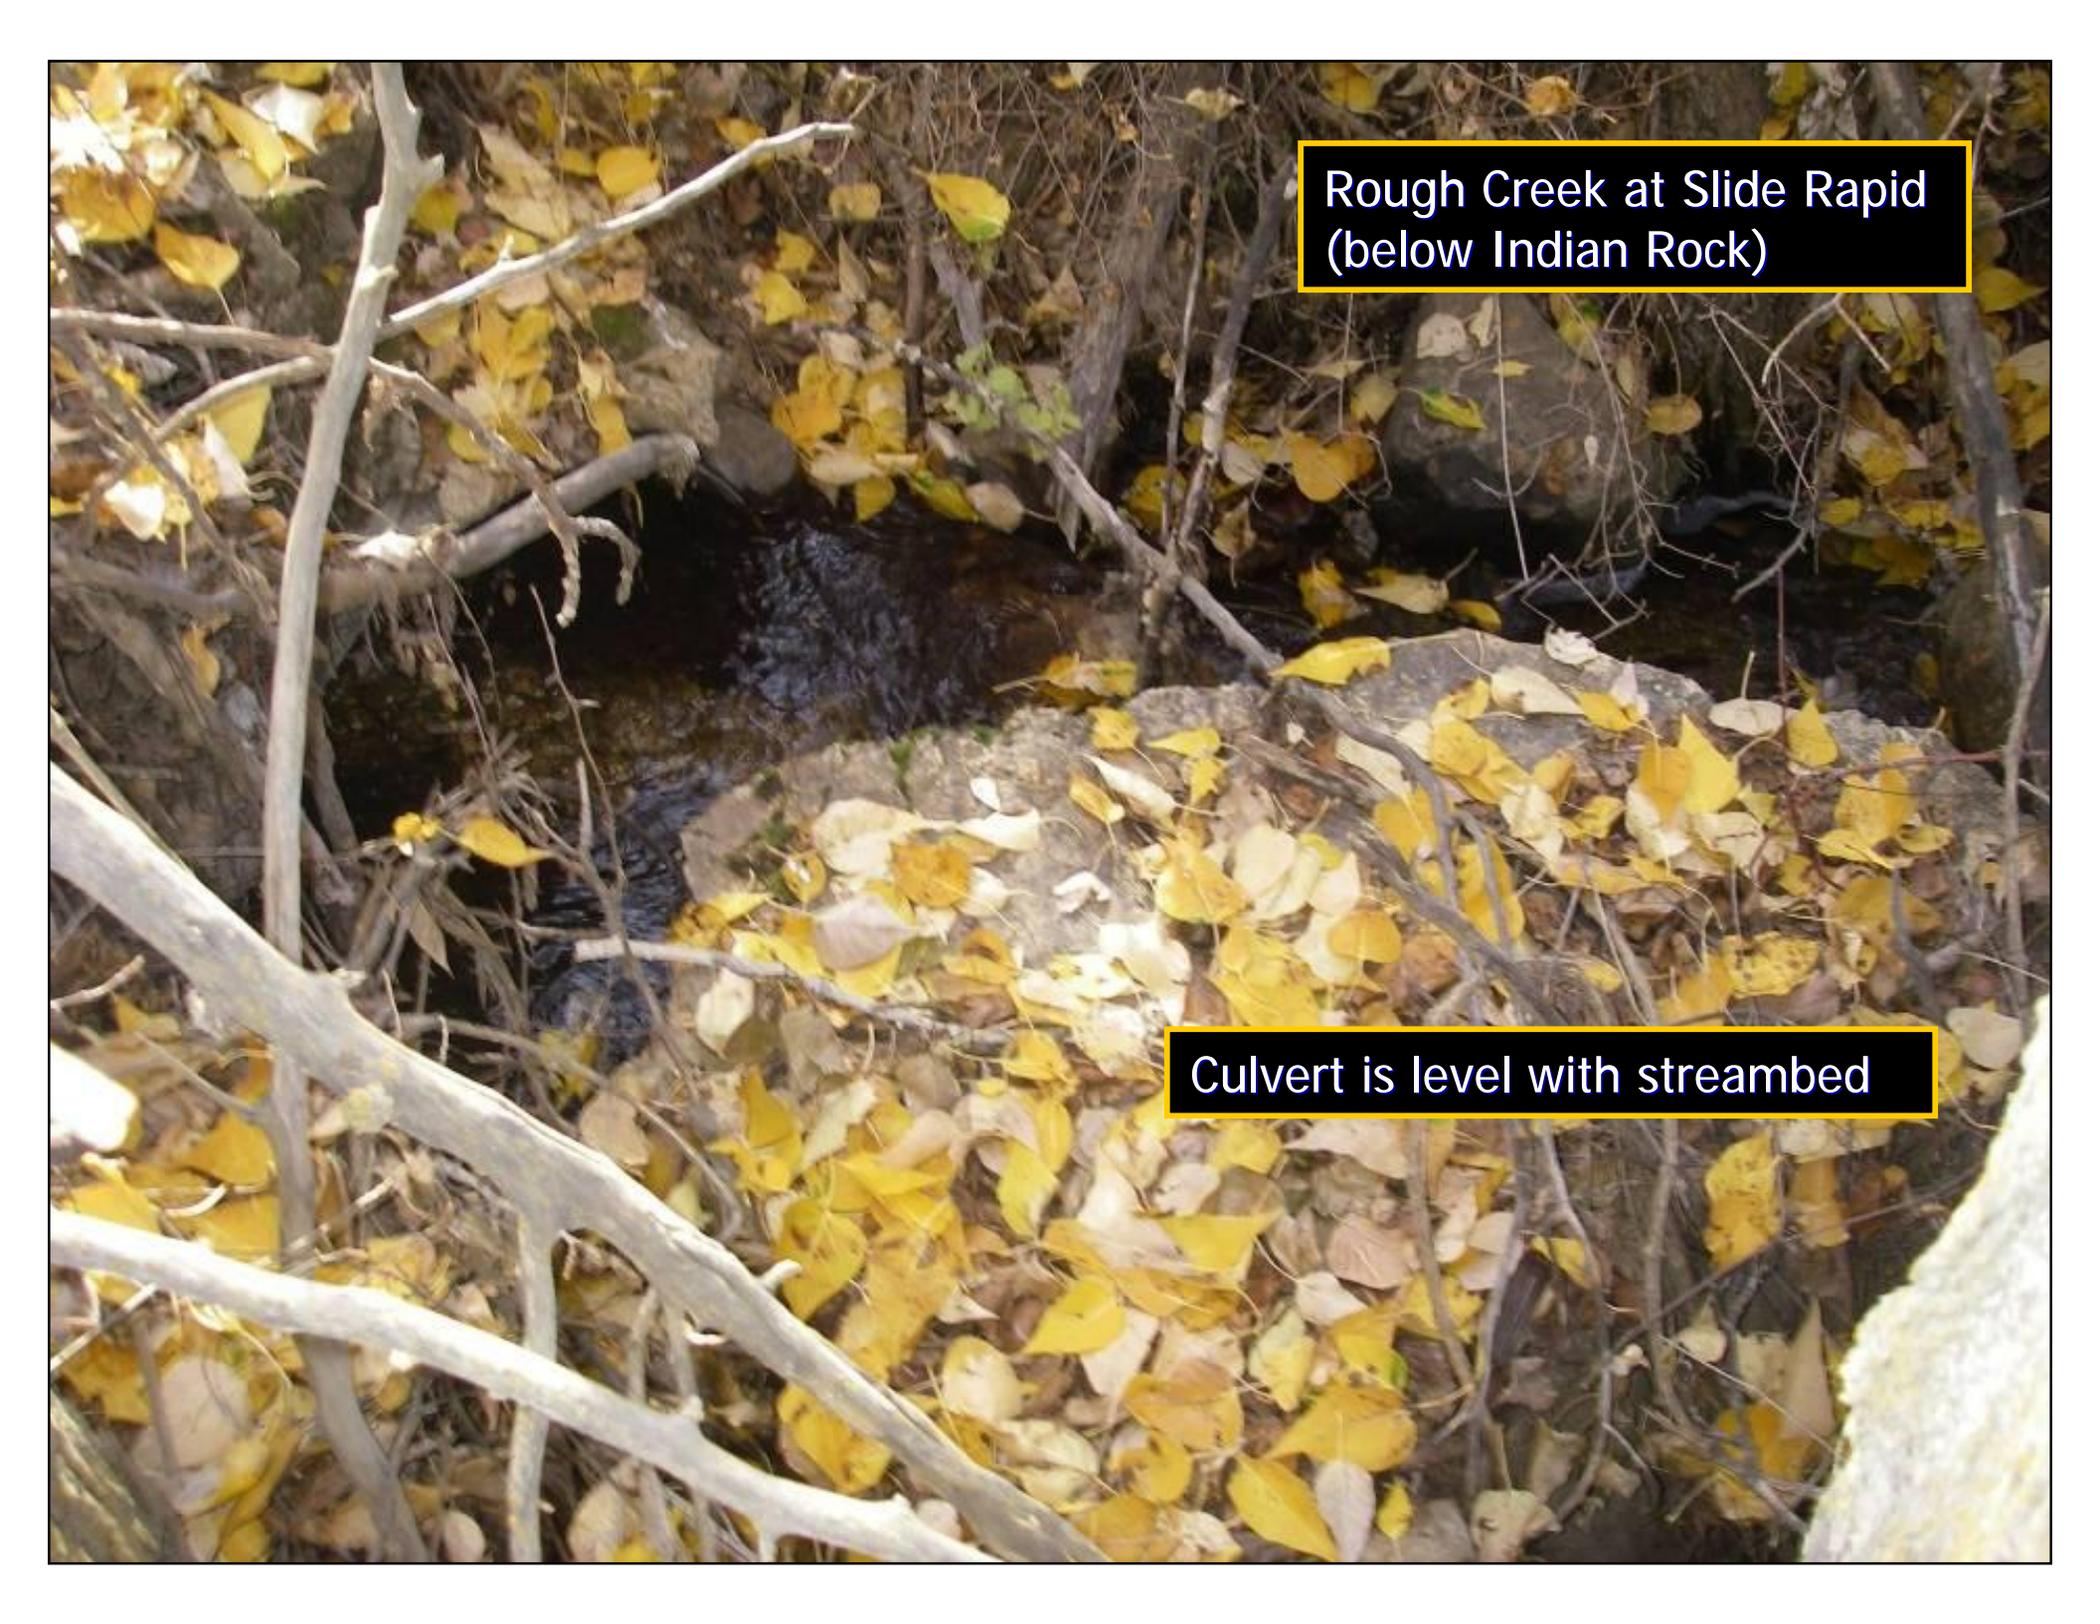
Rough Creek at Slide Rapid
(below Indian Rock)

Culvert is level with streambed

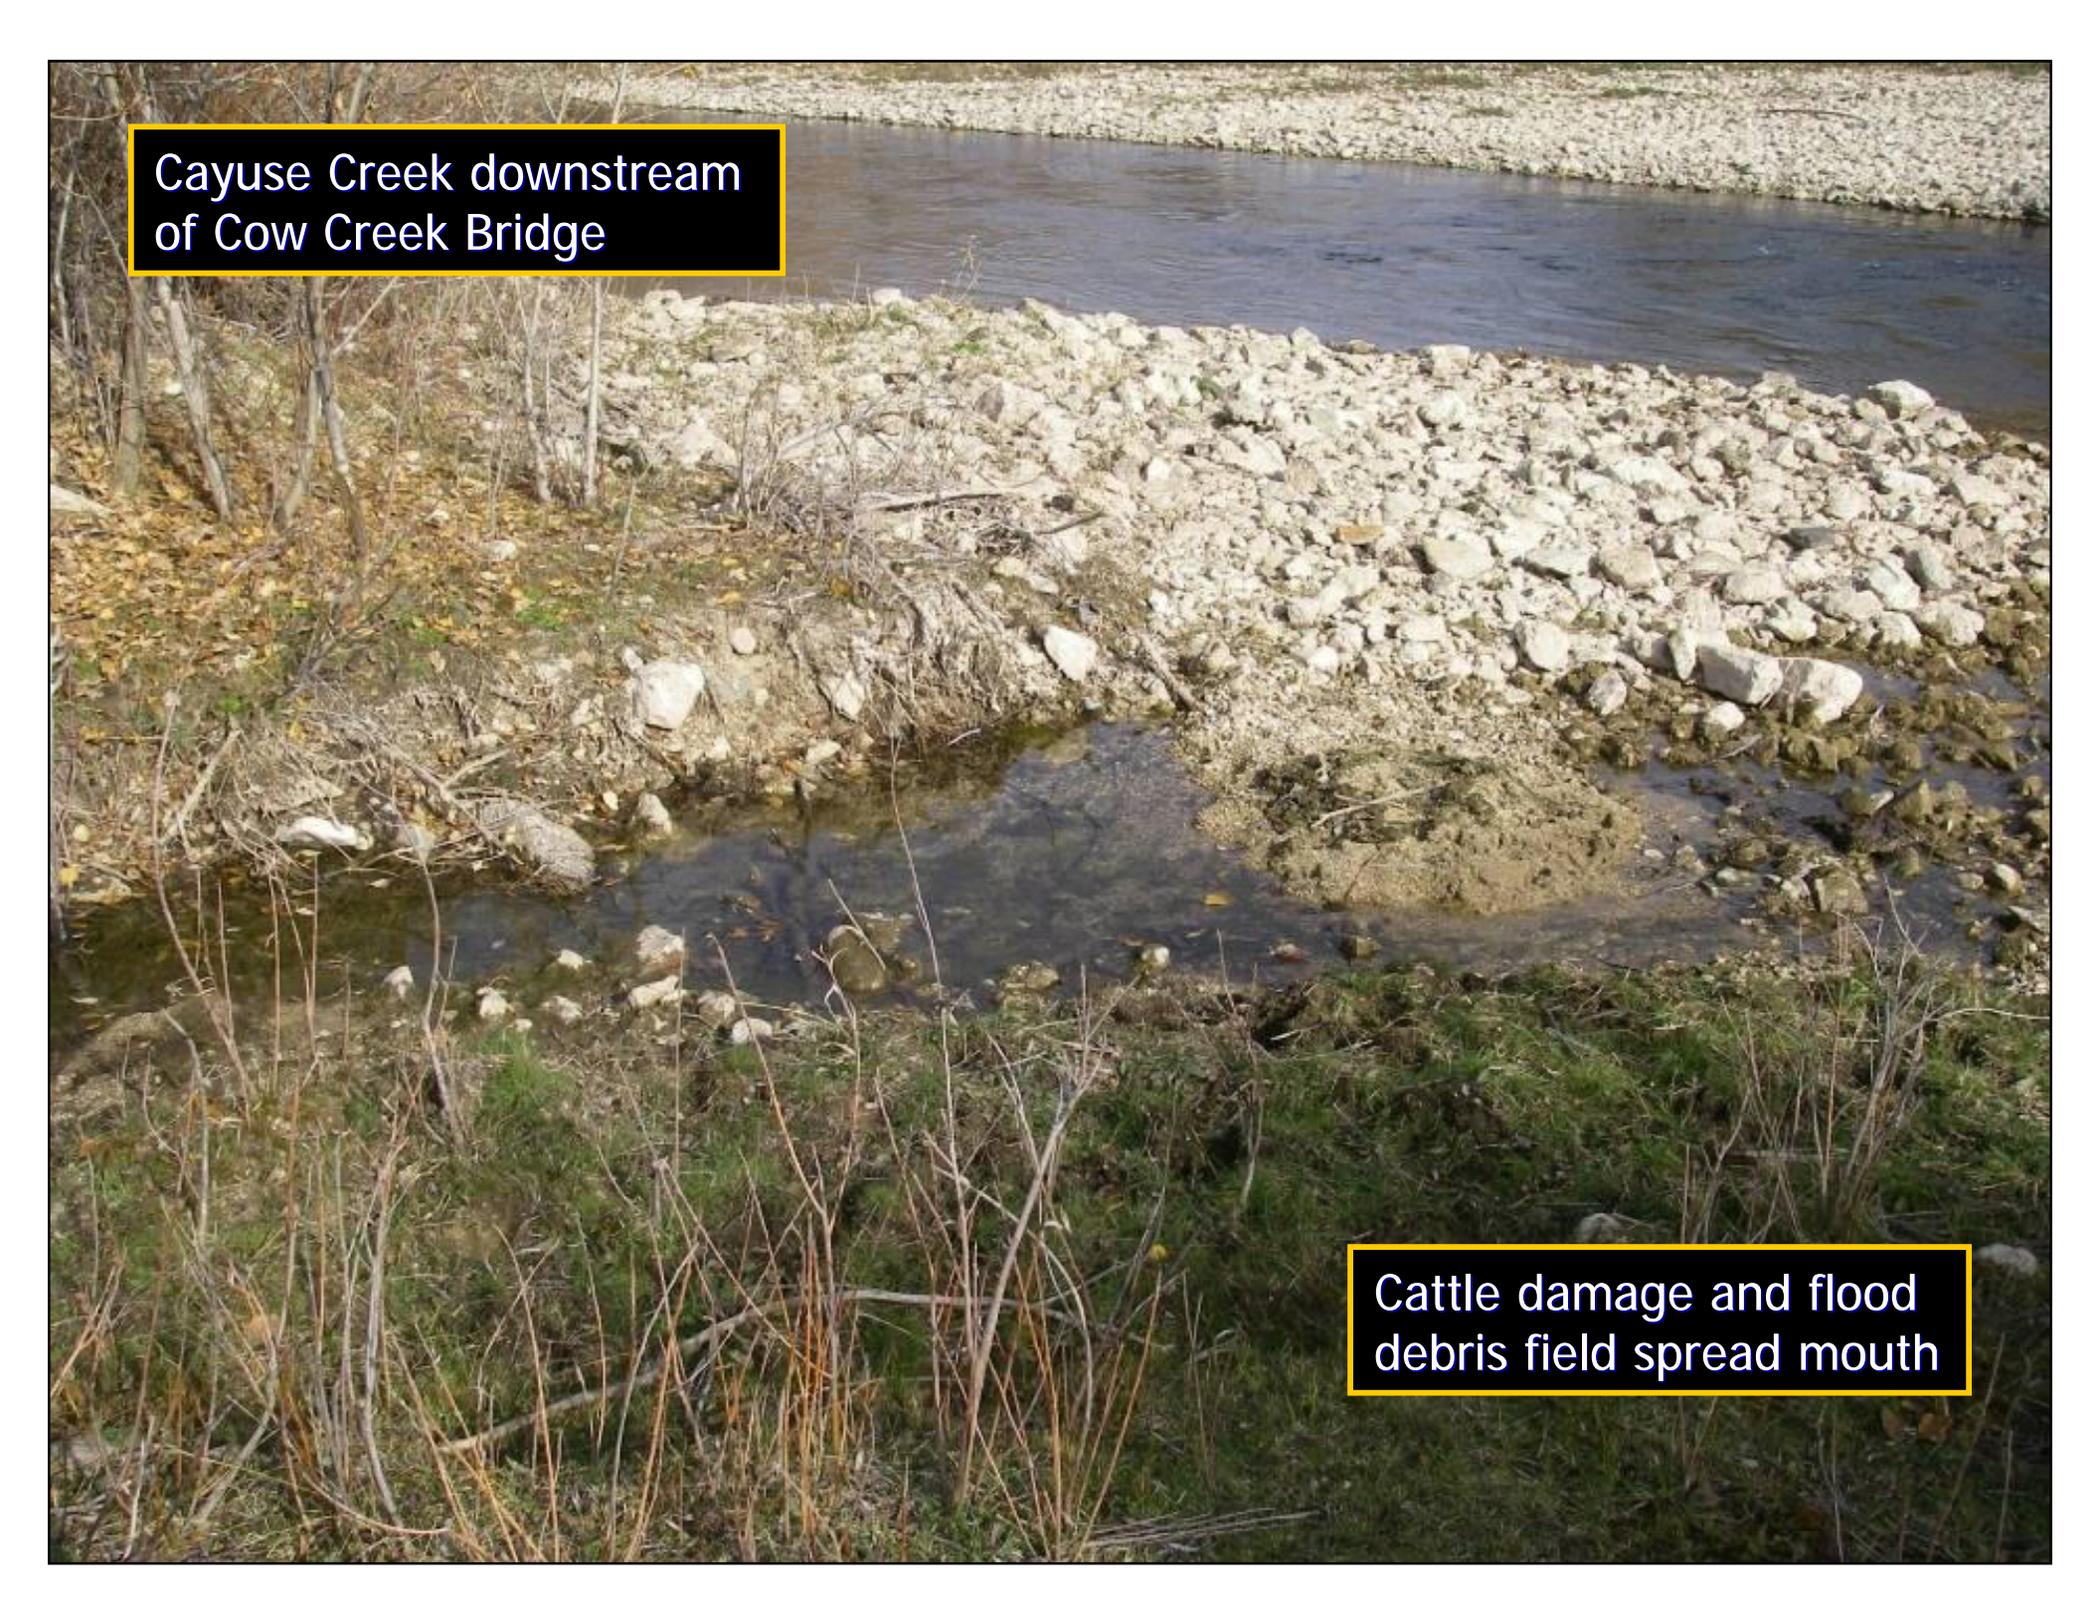
Cayuse Creek downstream
of Cow Creek Bridge

Cattle damage and flood
debris field spread mouth

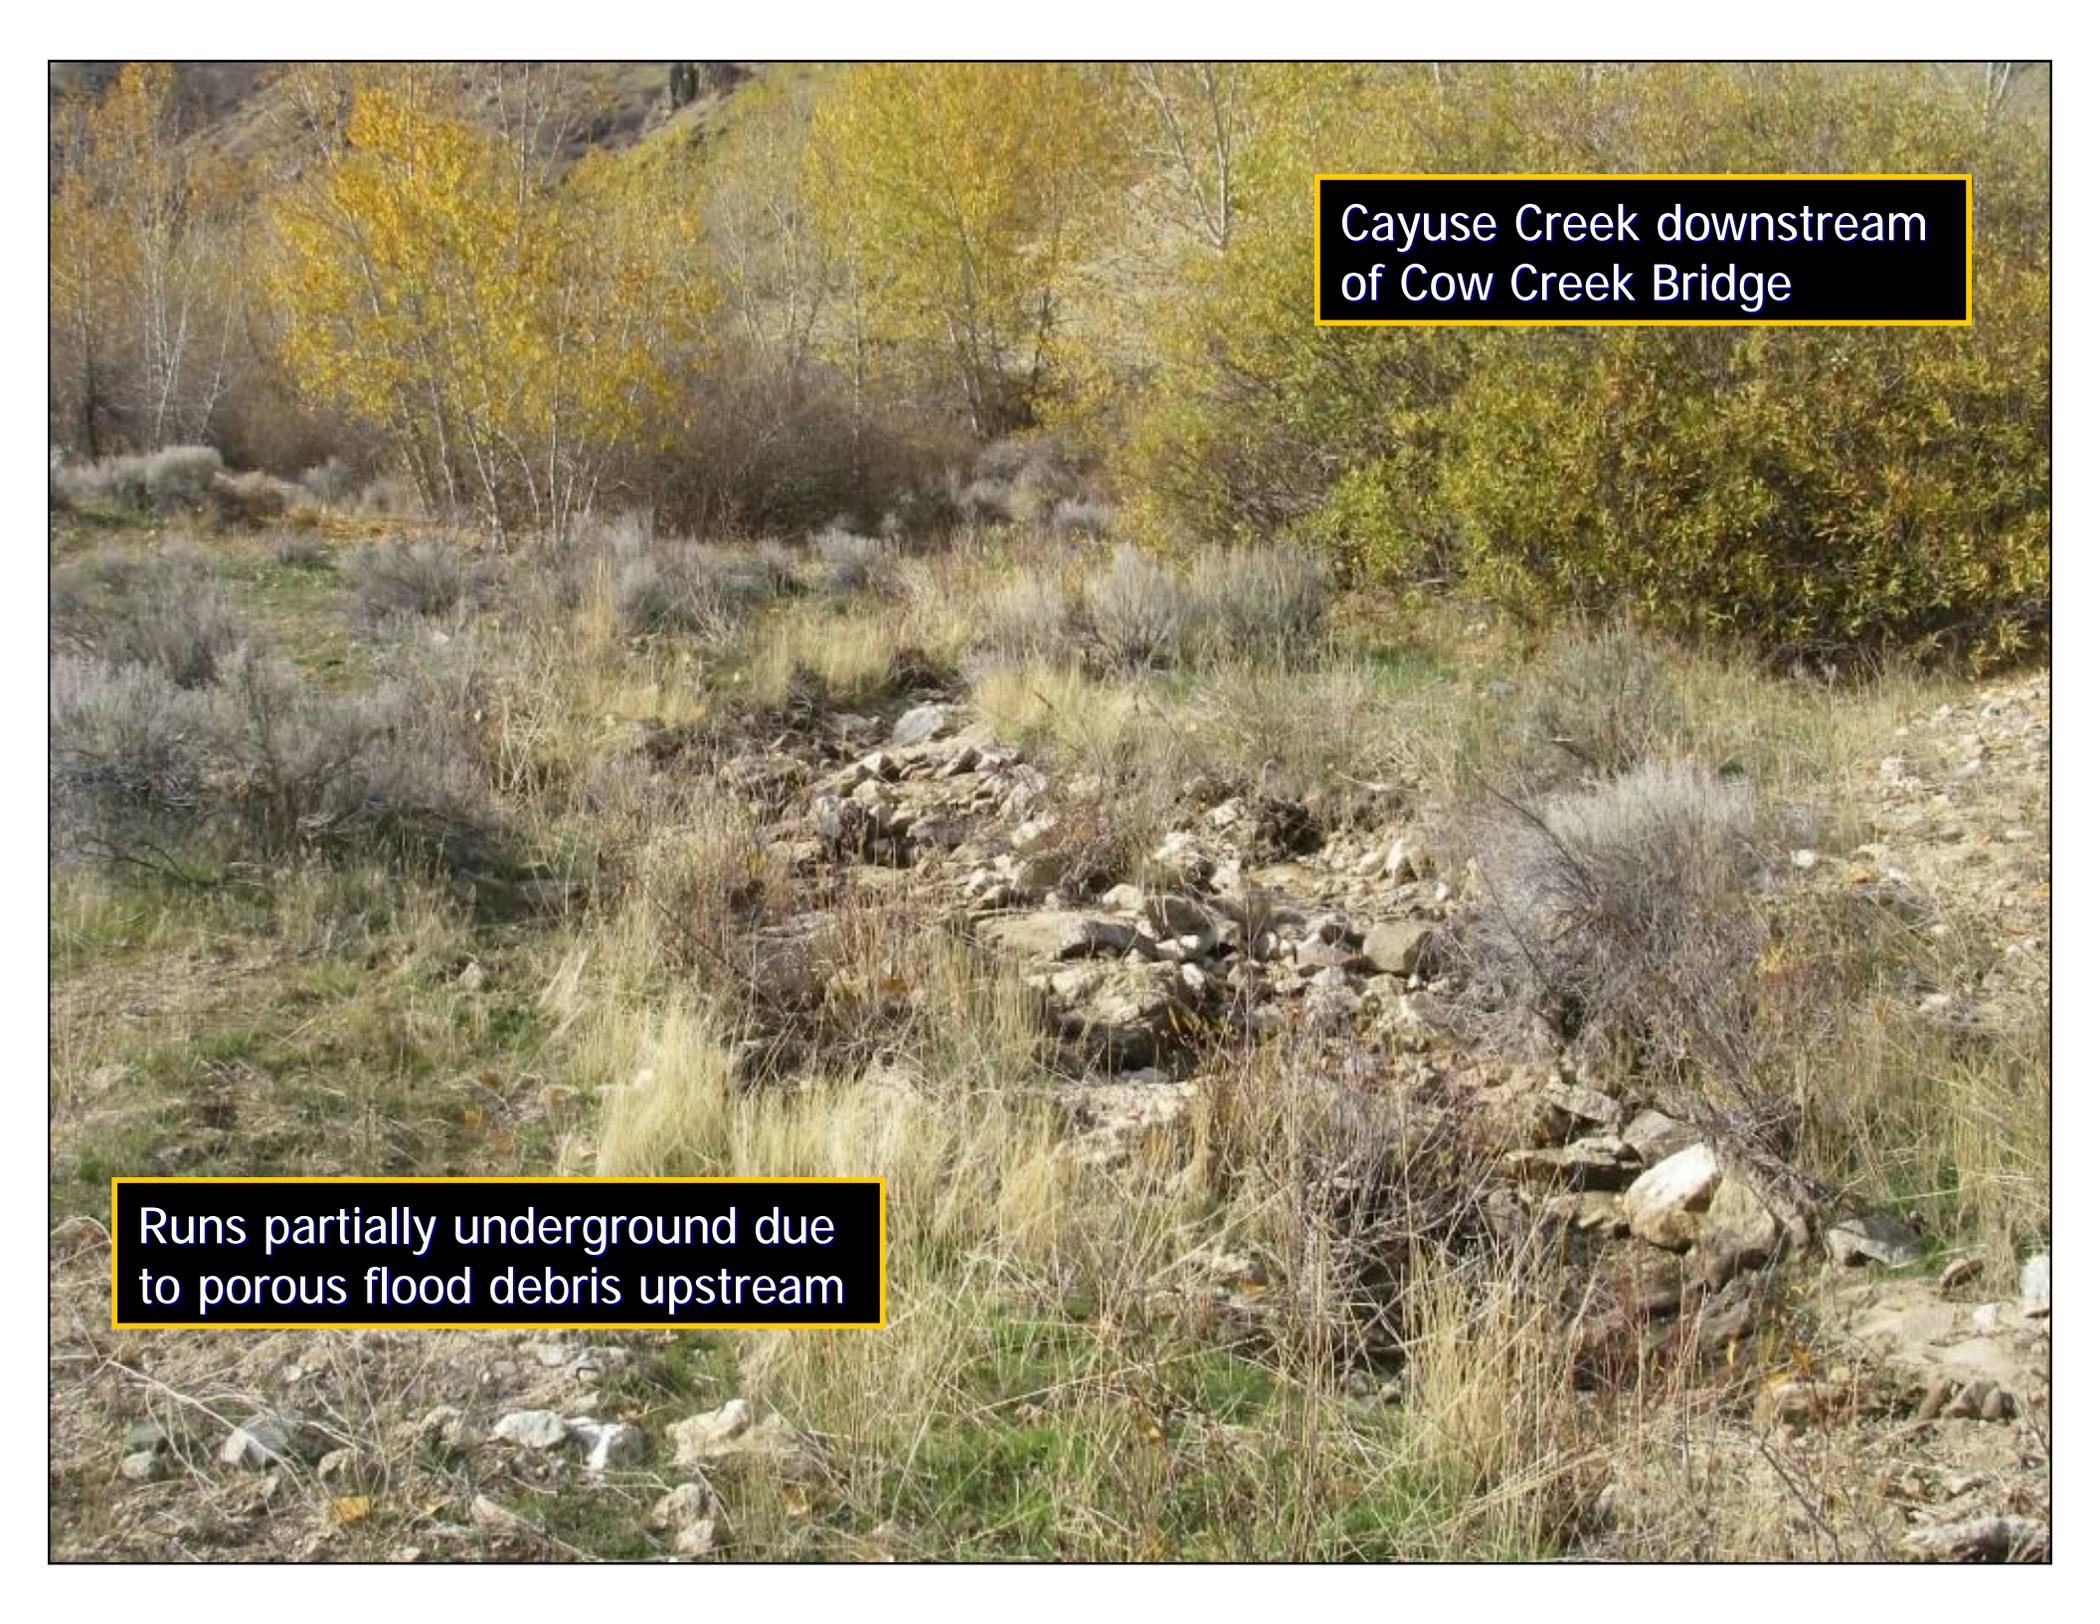
Cayuse Creek downstream
of Cow Creek Bridge

Runs partially underground due
to porous flood debris upstream

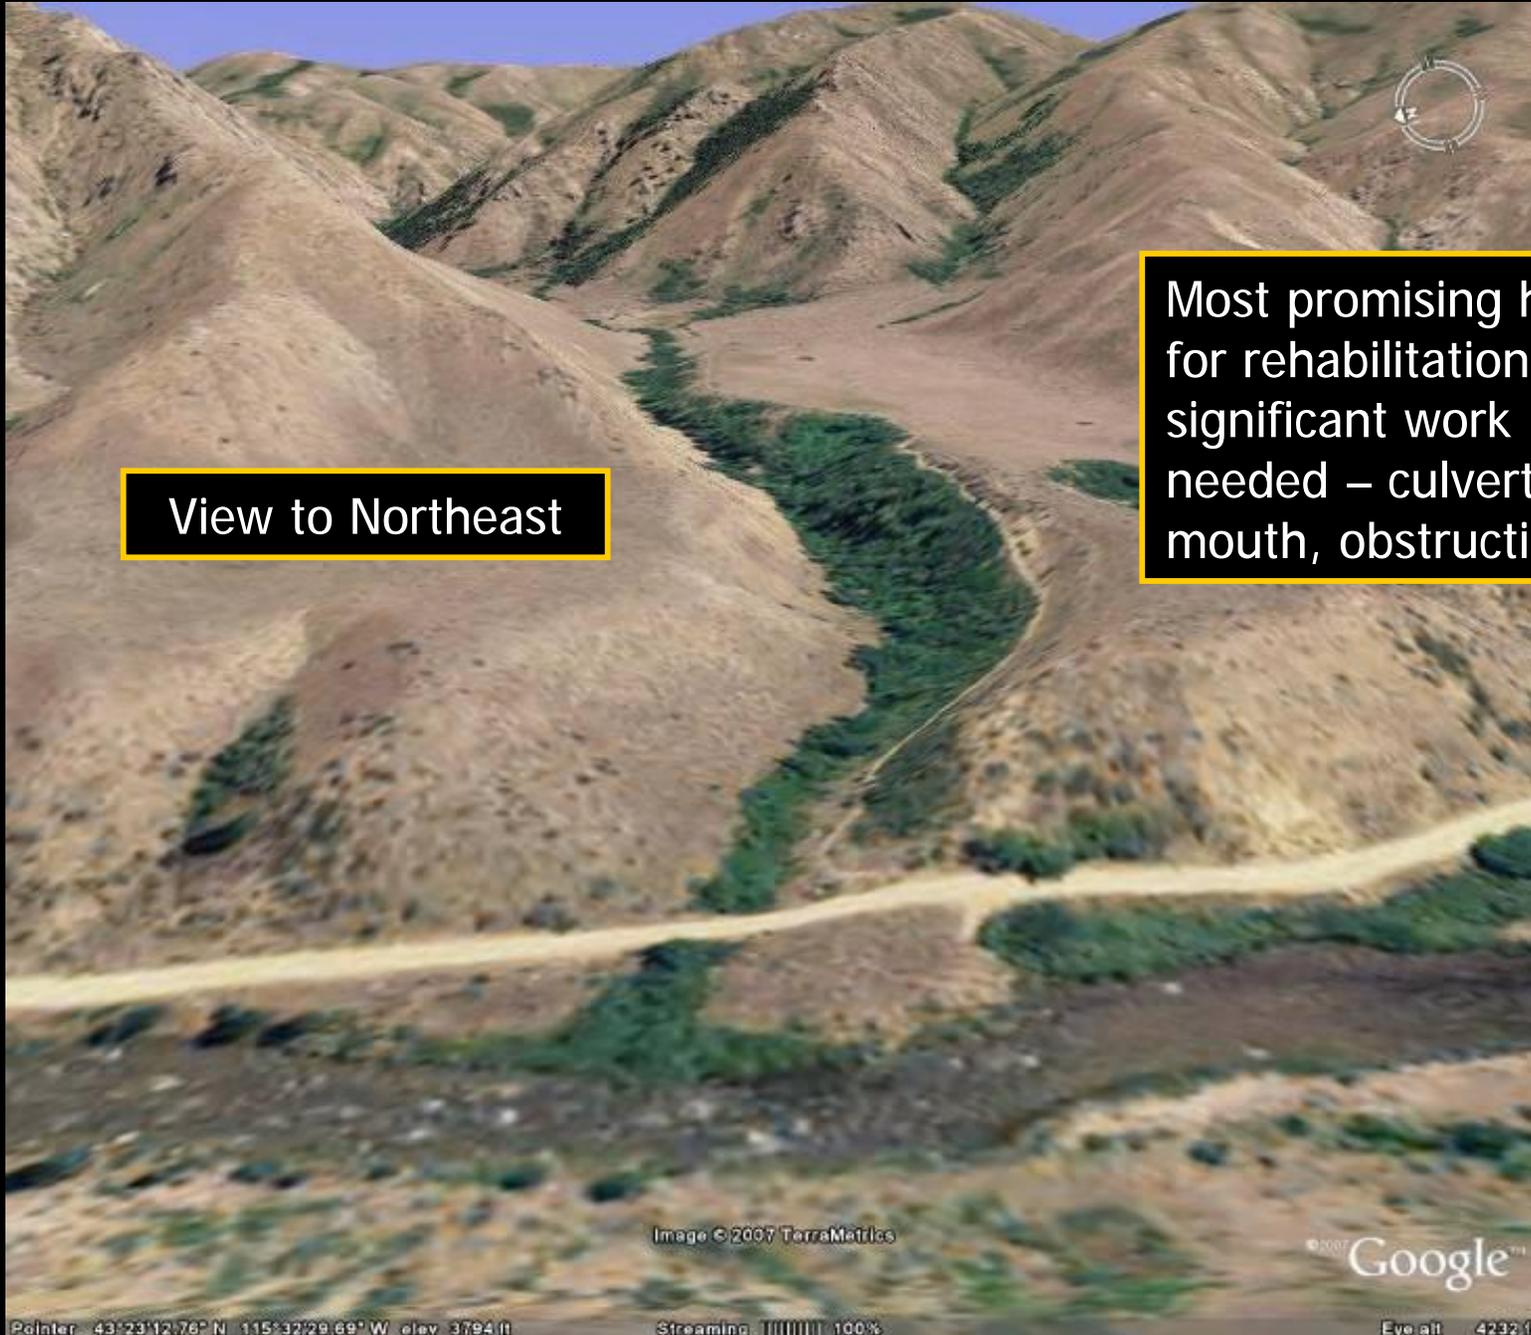
Granite Creek upstream of Pine Tree Rapid

Most promising habitat for rehabilitation but significant work needed – culvert, mouth, obstructions

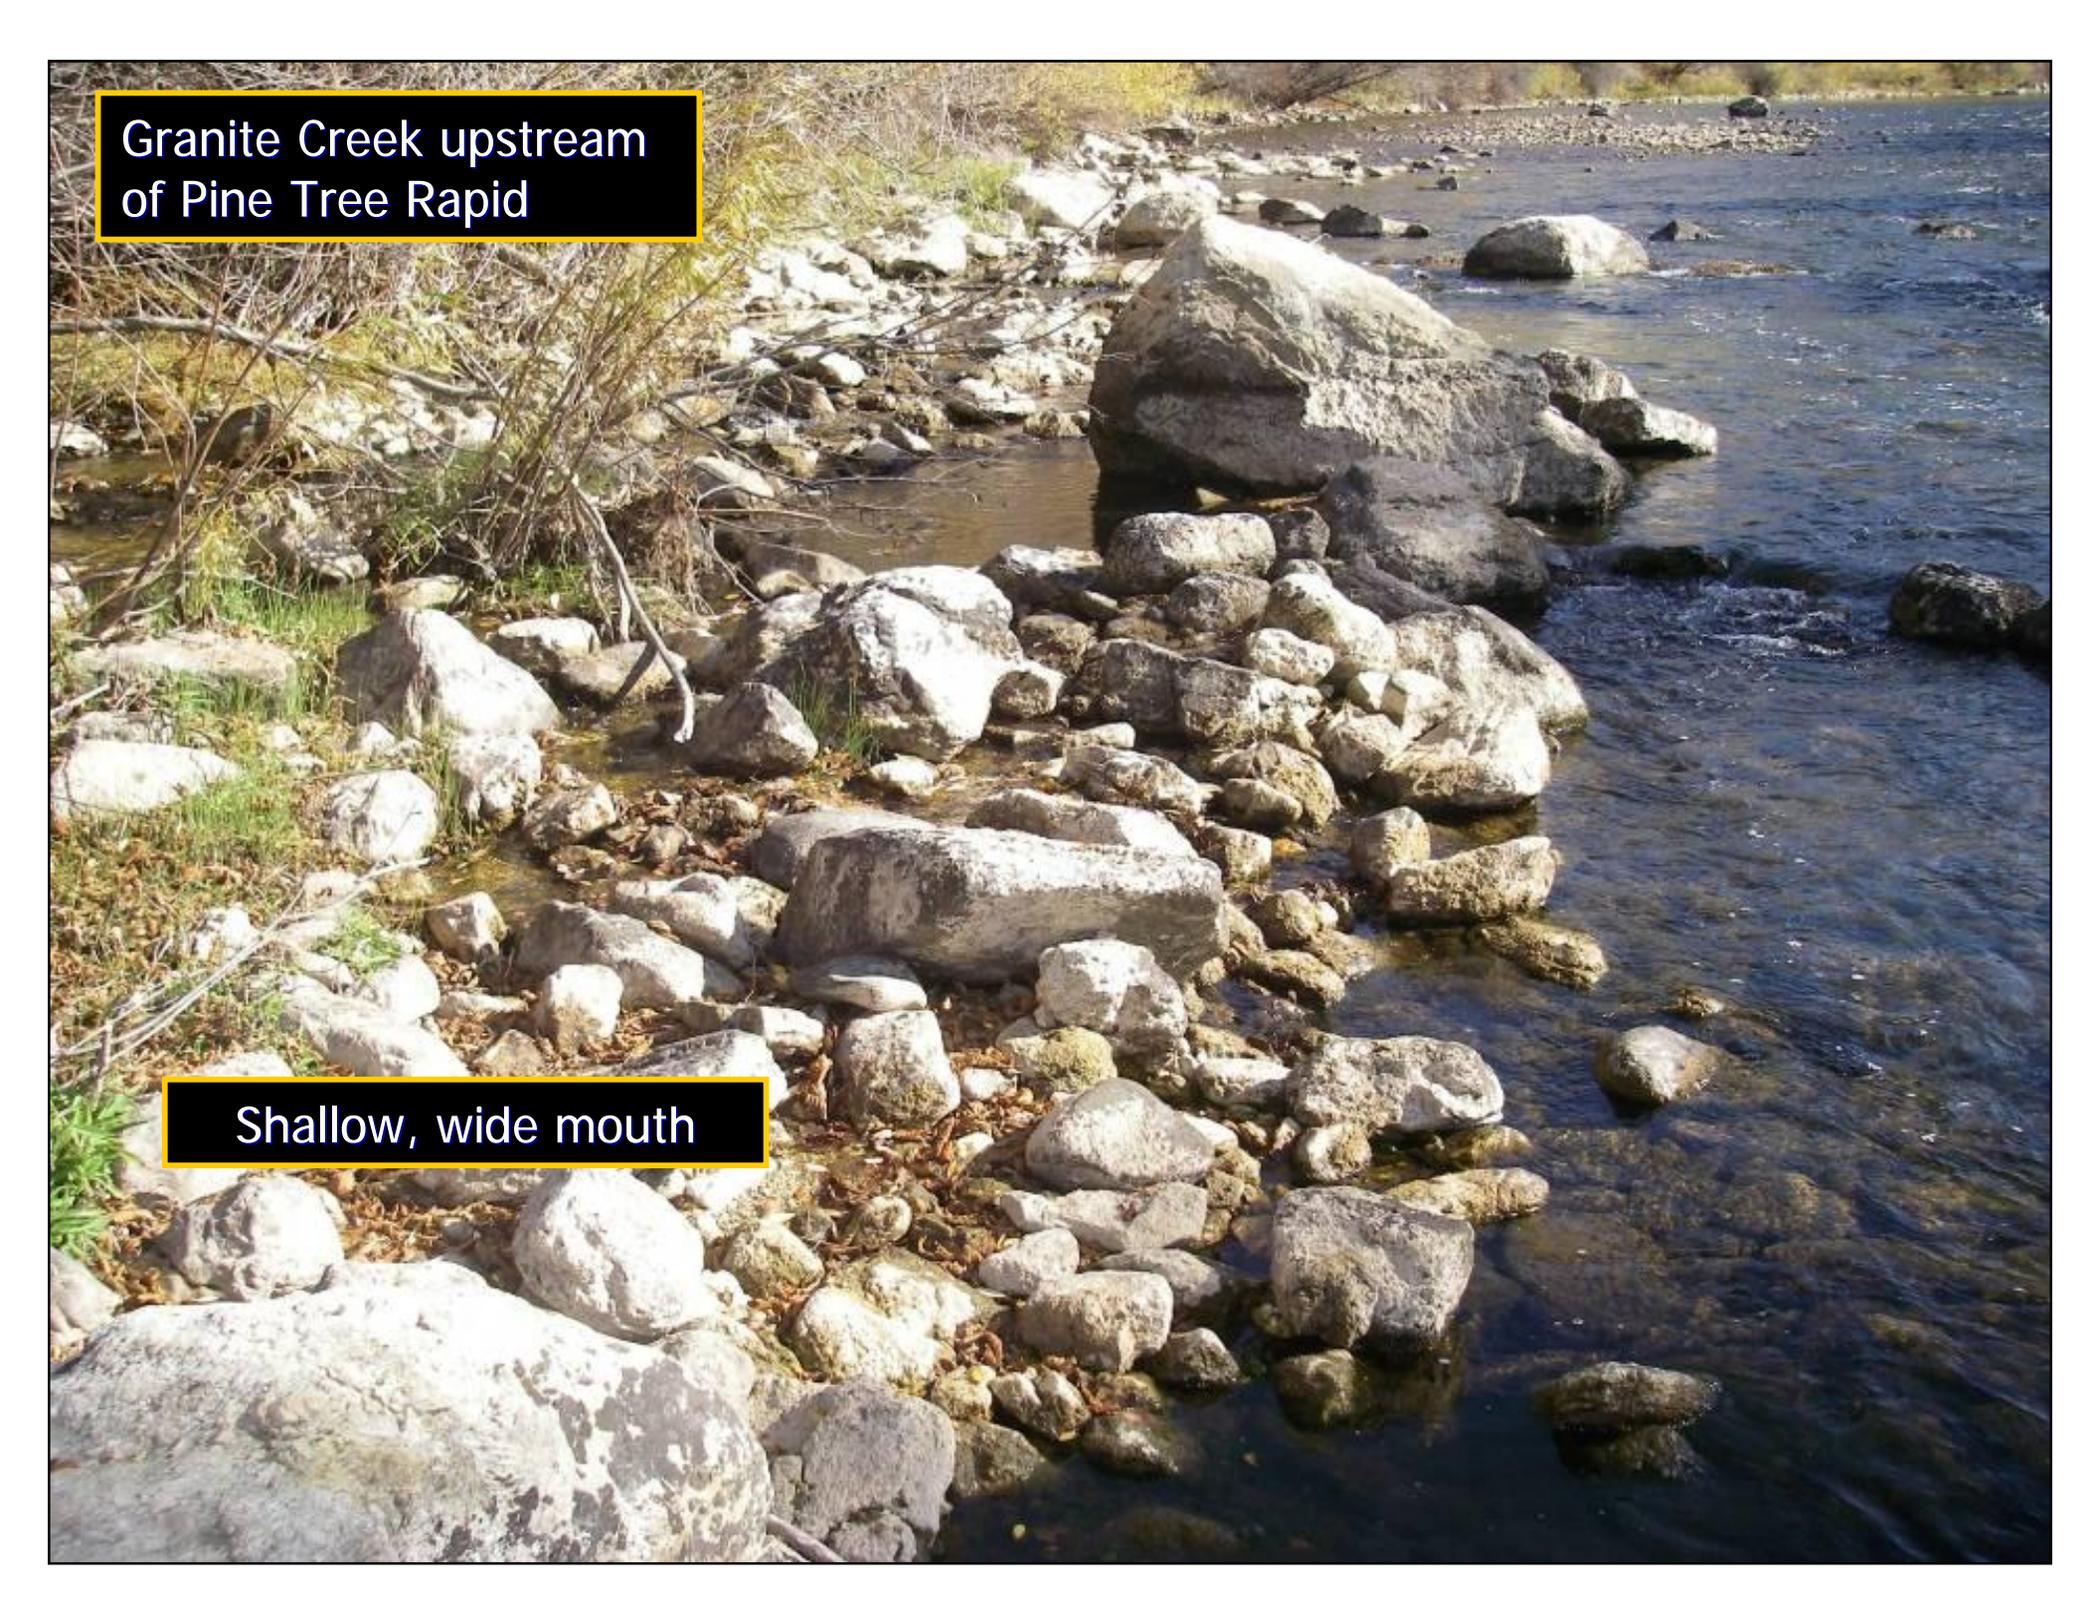
Granite Creek upstream
of Pine Tree Rapid

Shallow, wide mouth

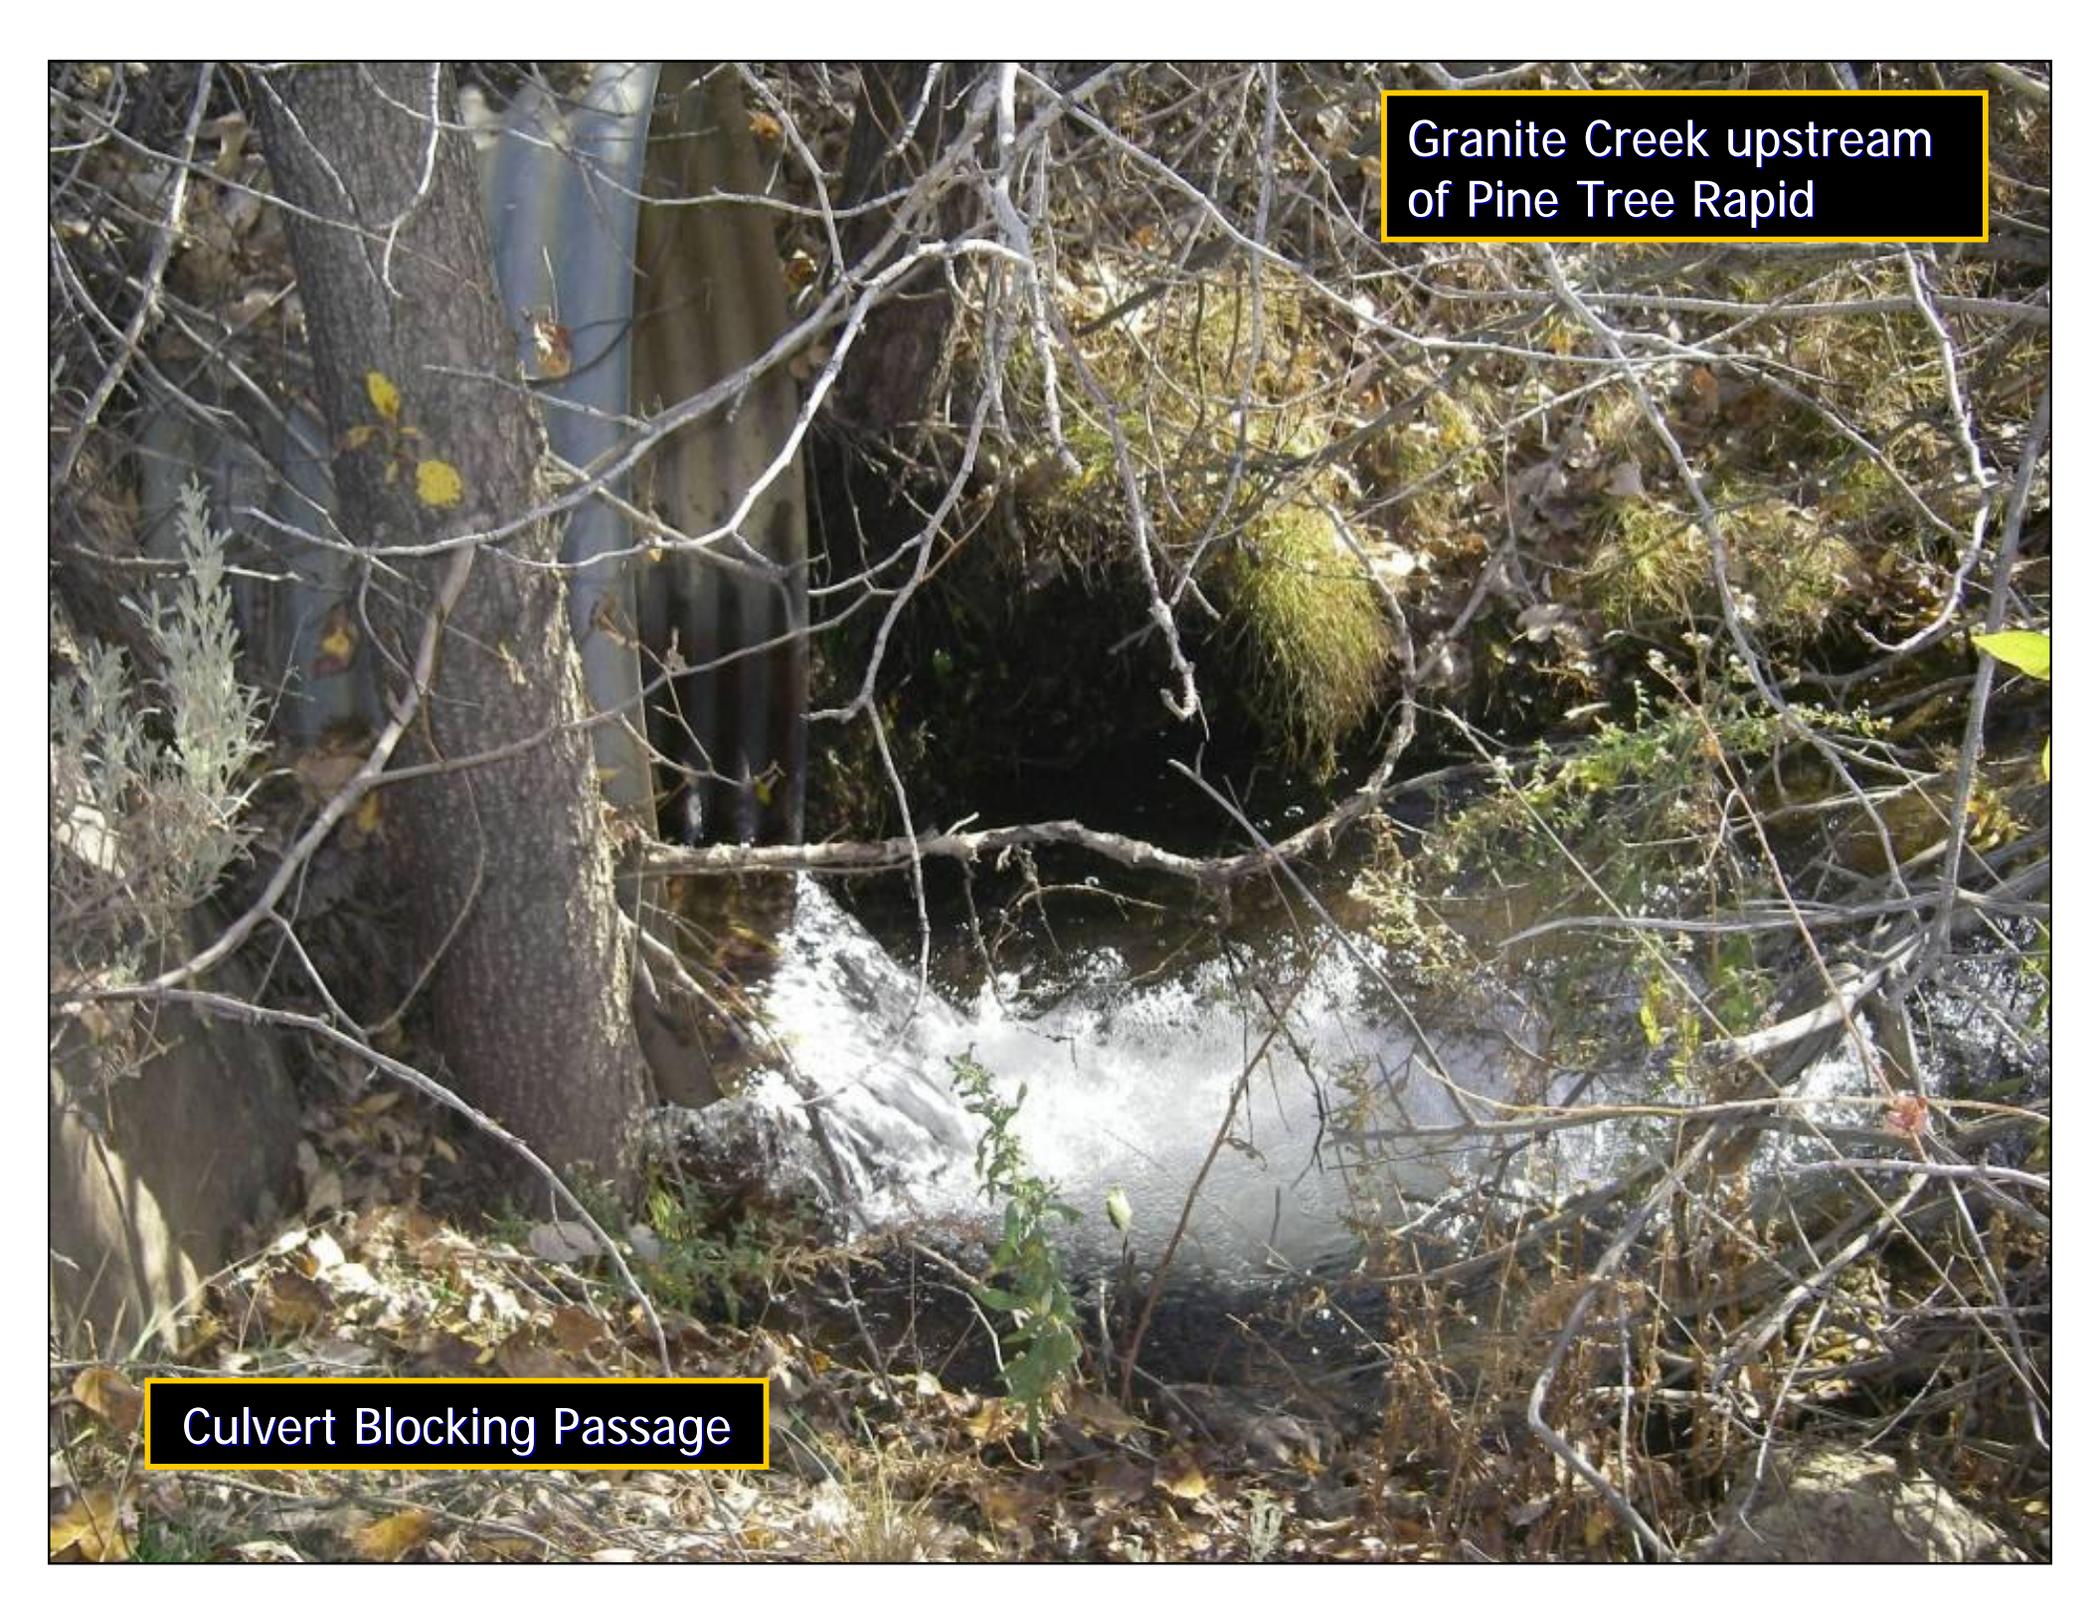
Granite Creek upstream
of Pine Tree Rapid

Culvert Blocking Passage
