Potential Spawning
Tributaries
for

The South Fork Boise River

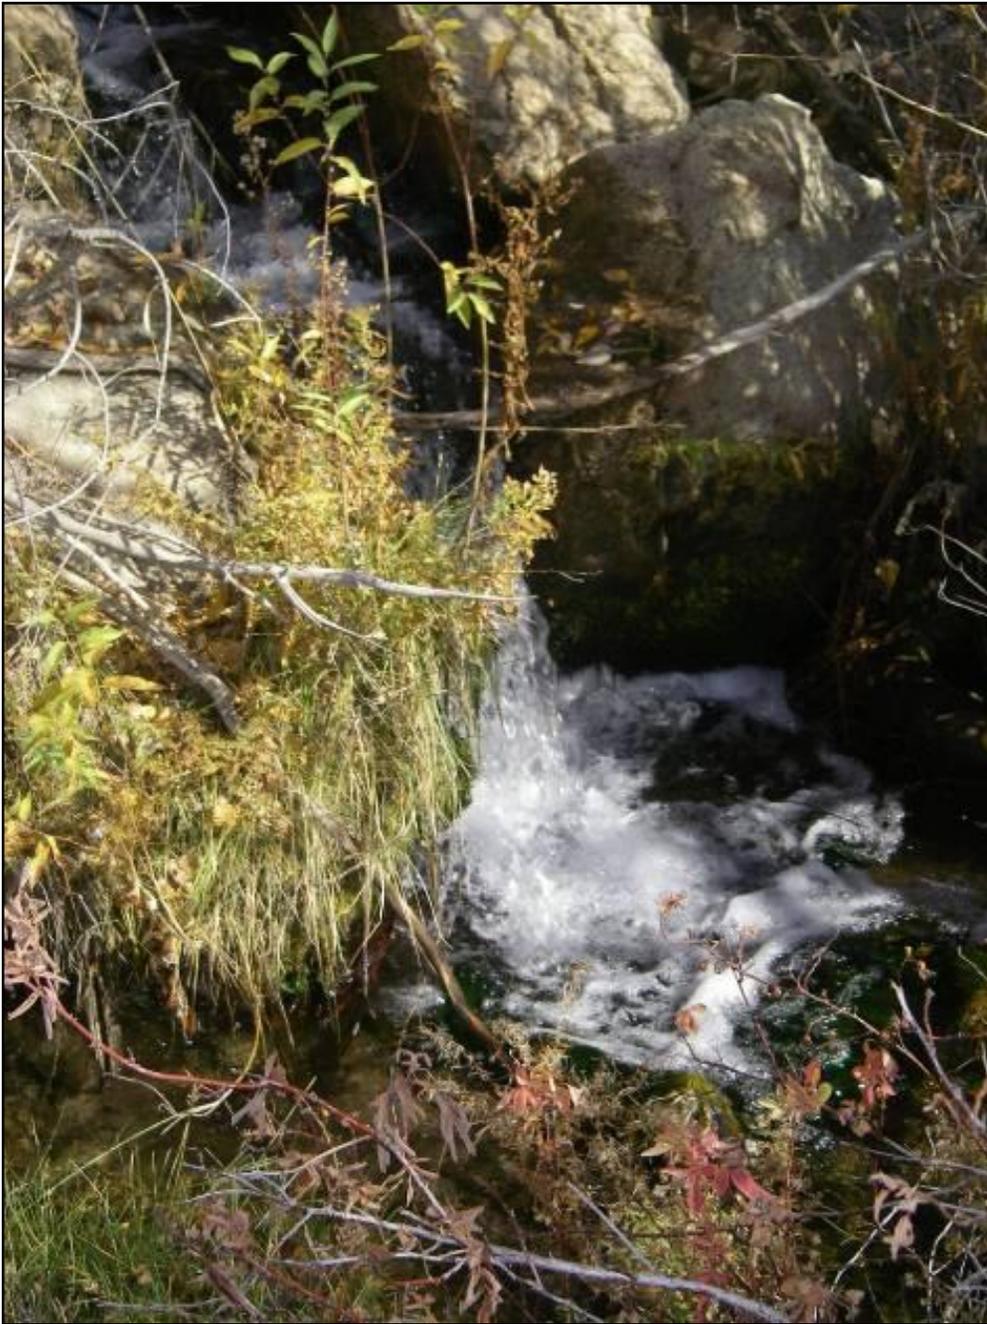
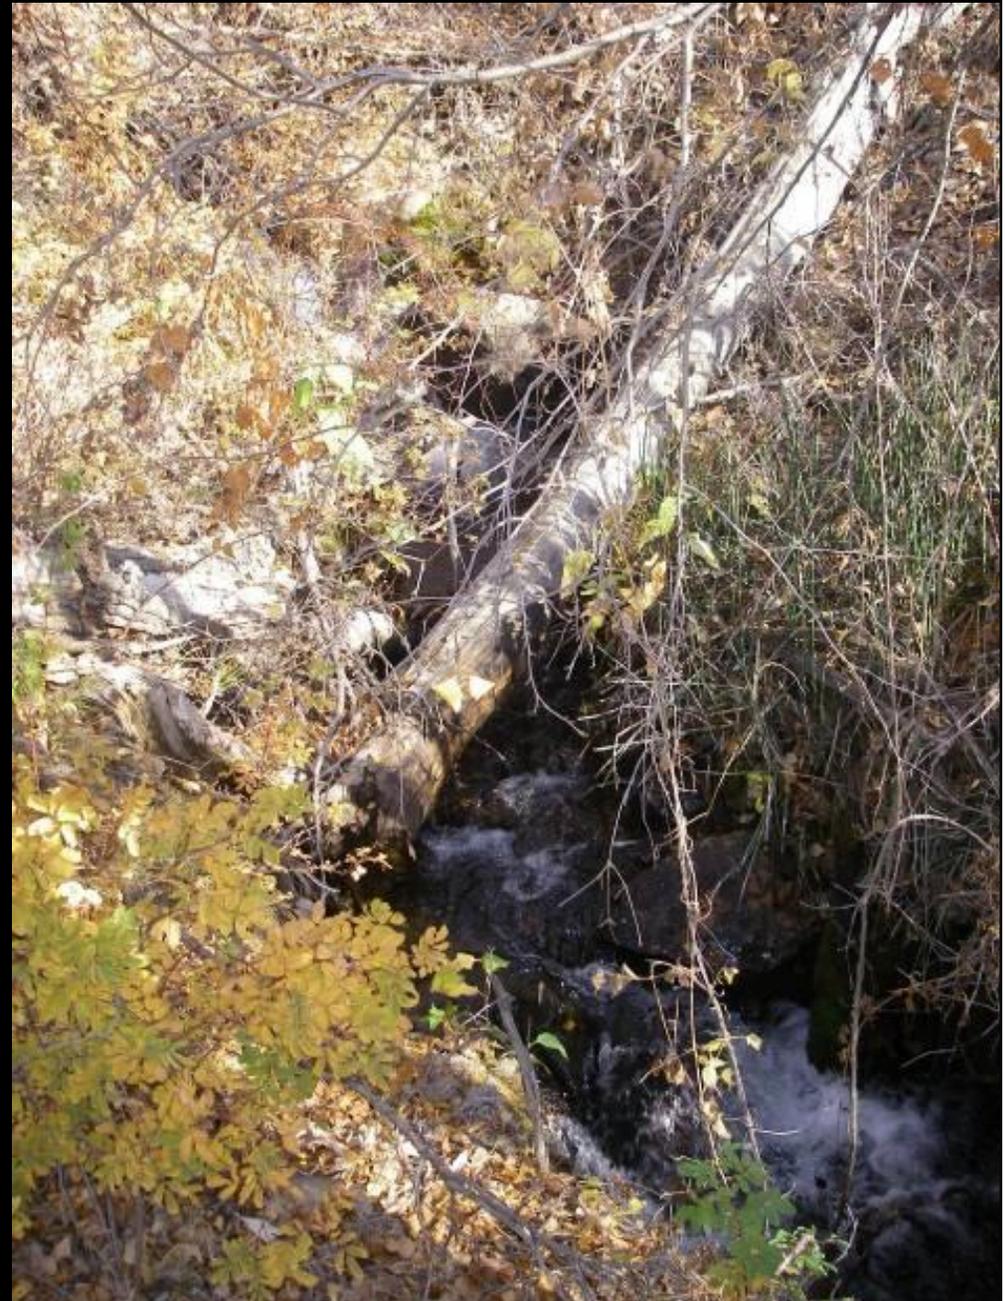
Granite Creek upstream
of Pine Tree Rapid

4 foot high cascades impeding passage

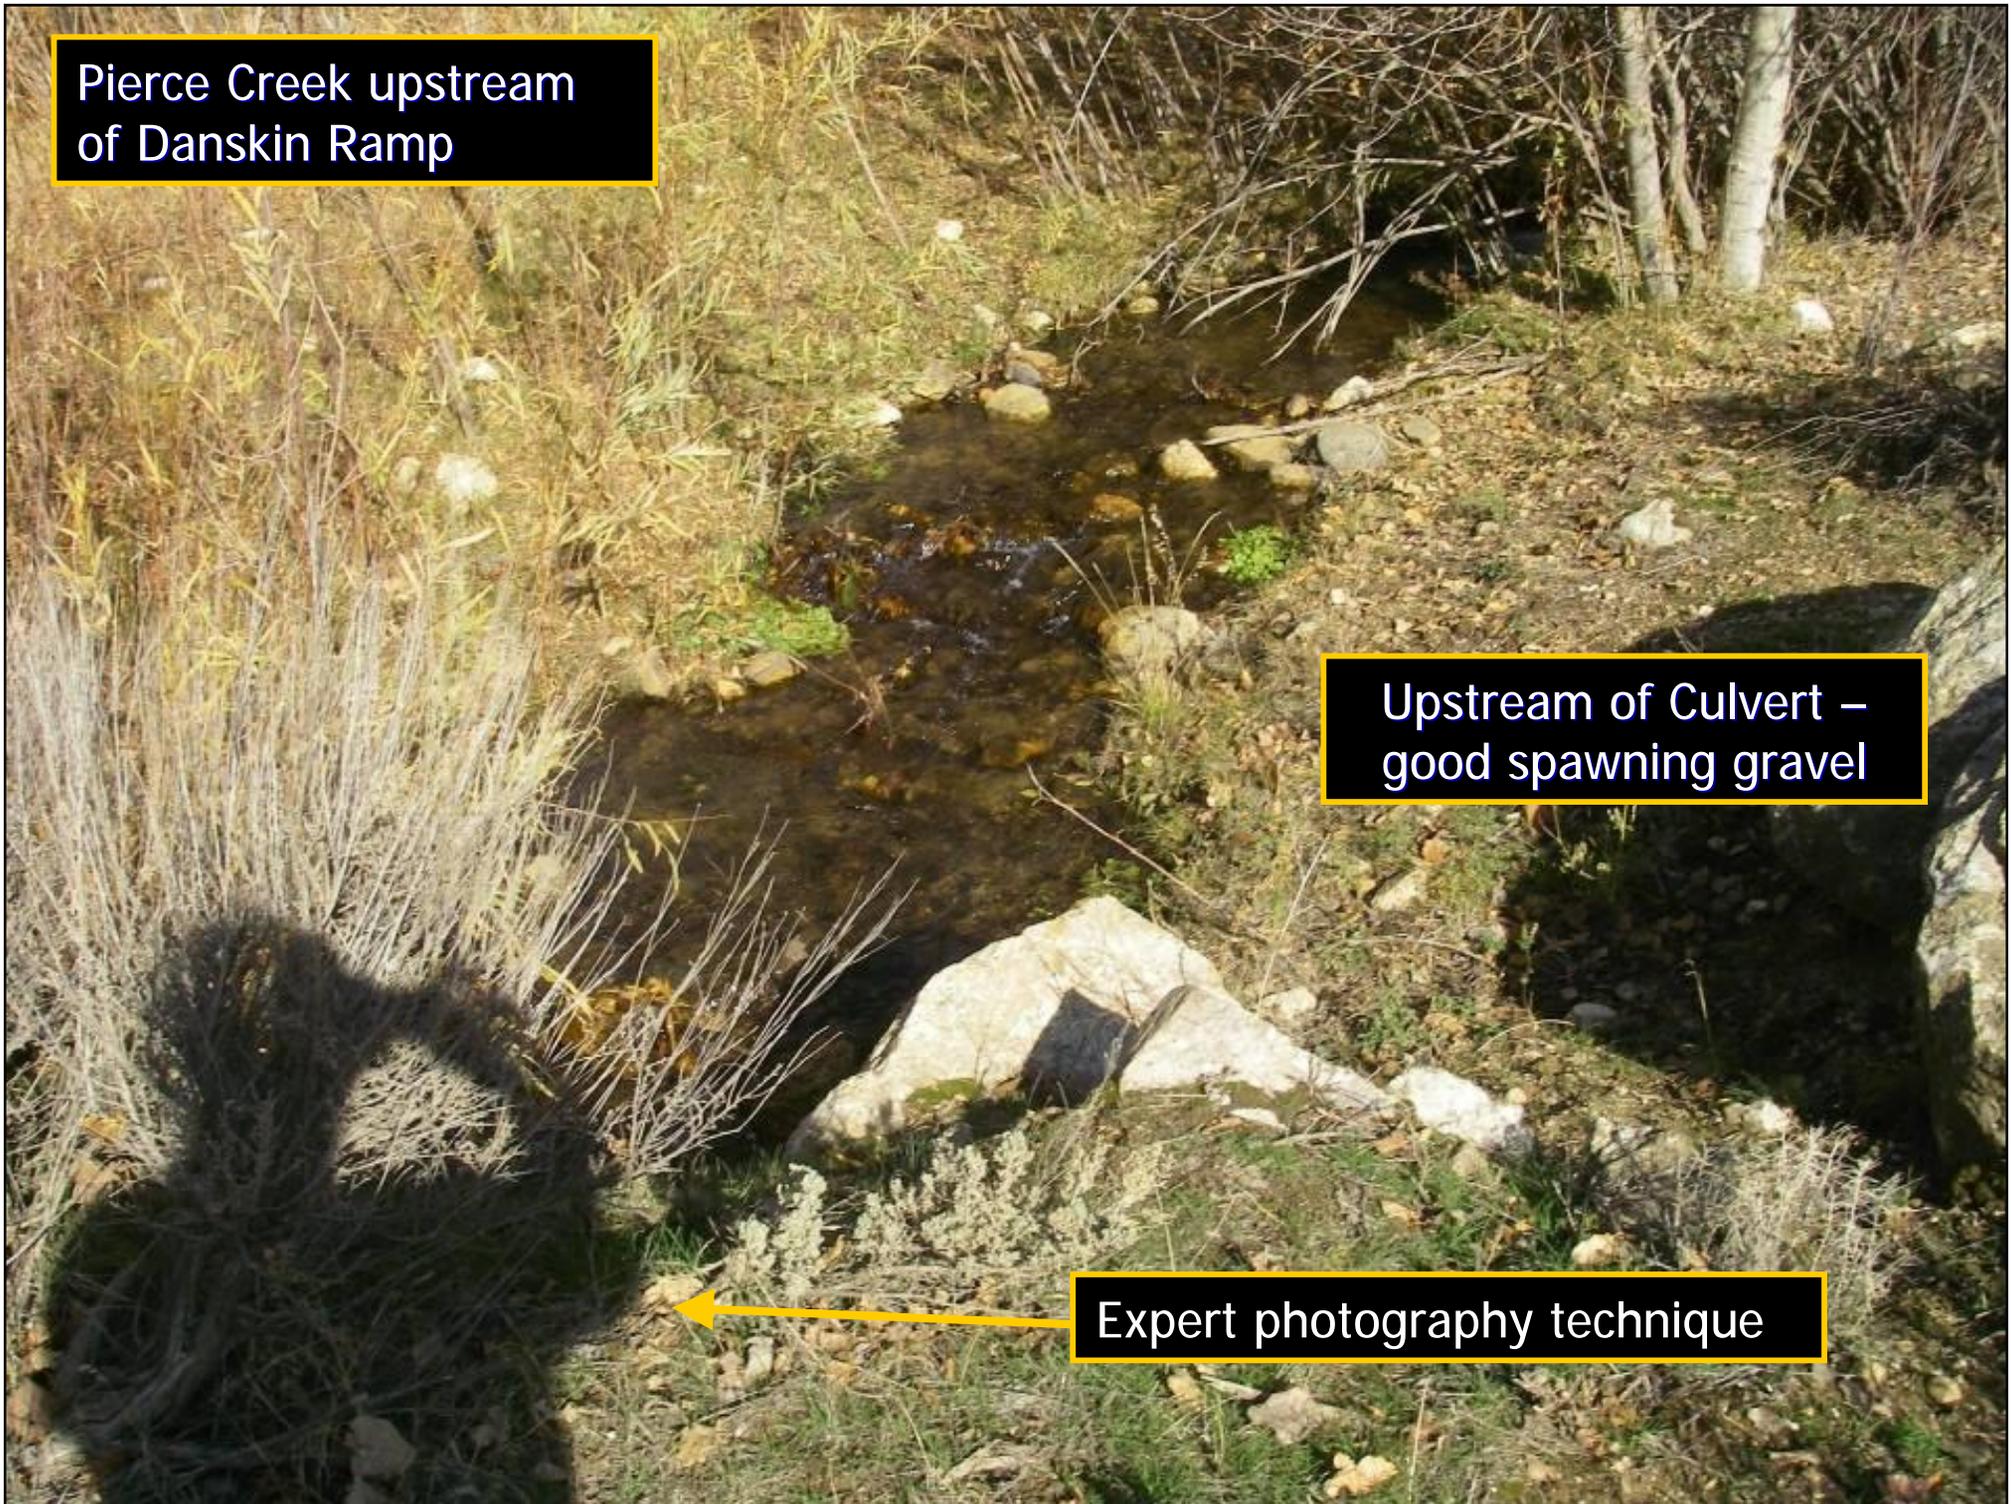
Pierce Creek upstream
of Danskin Ramp

Upstream of Culvert –
good spawning gravel

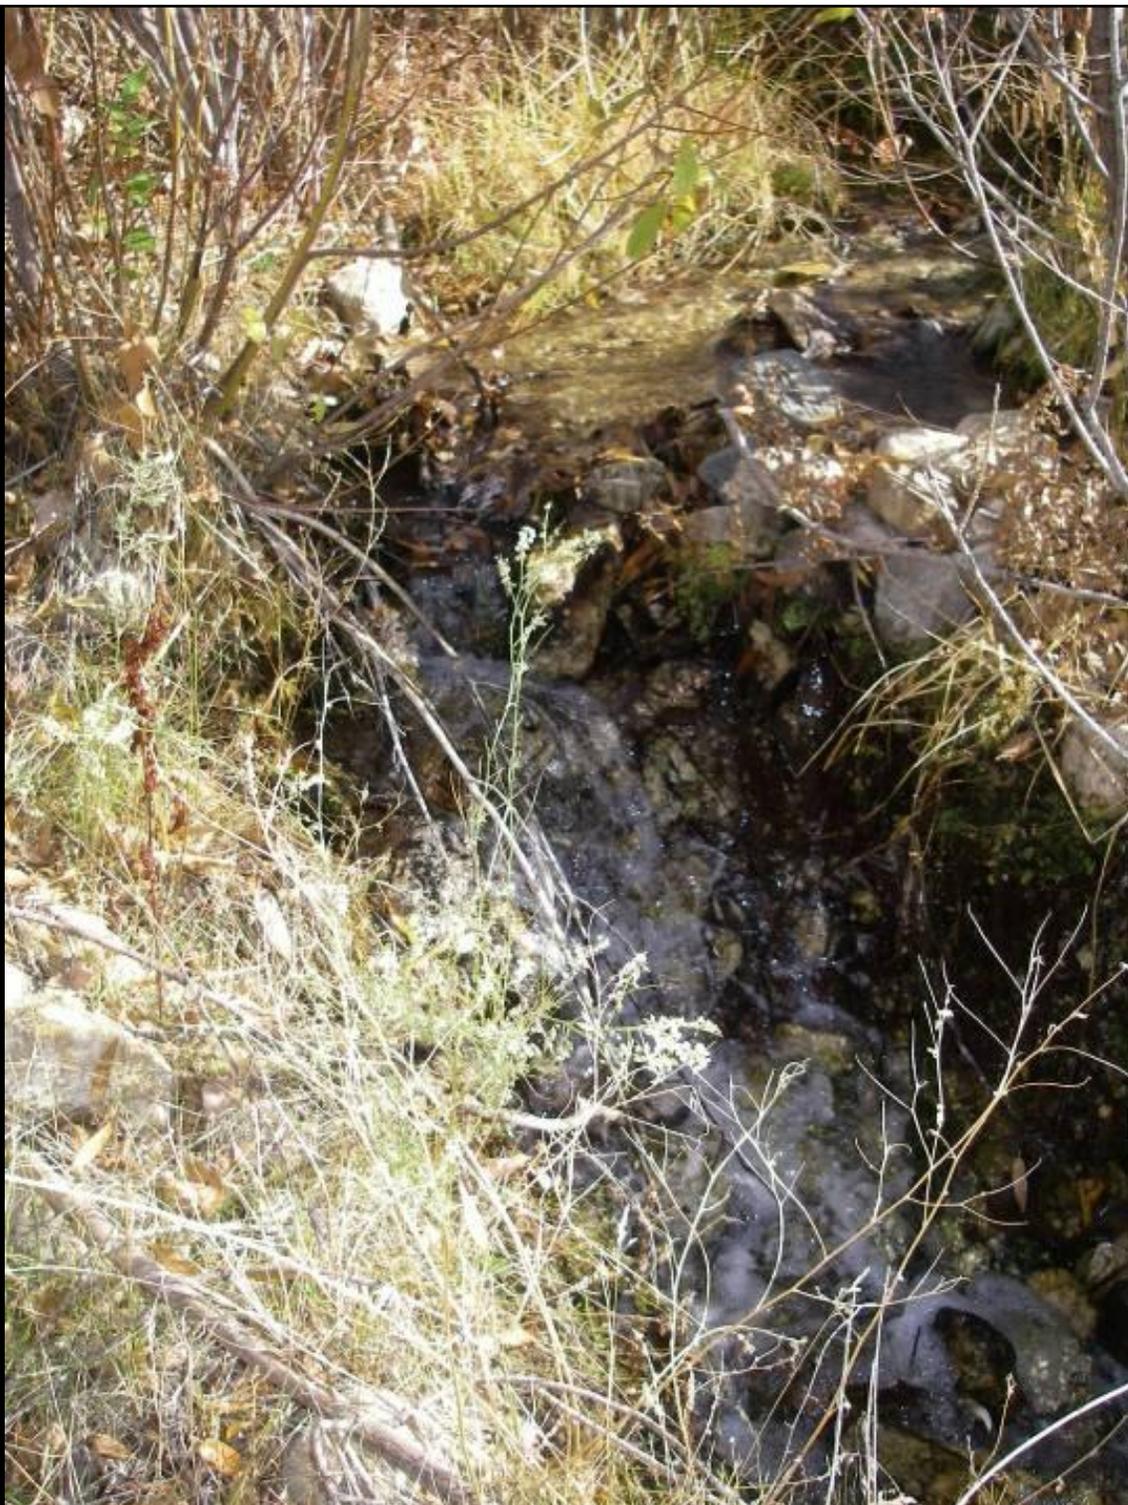
Pierce Creek upstream
of new Danskin access

Cascade near stream
mouth to river

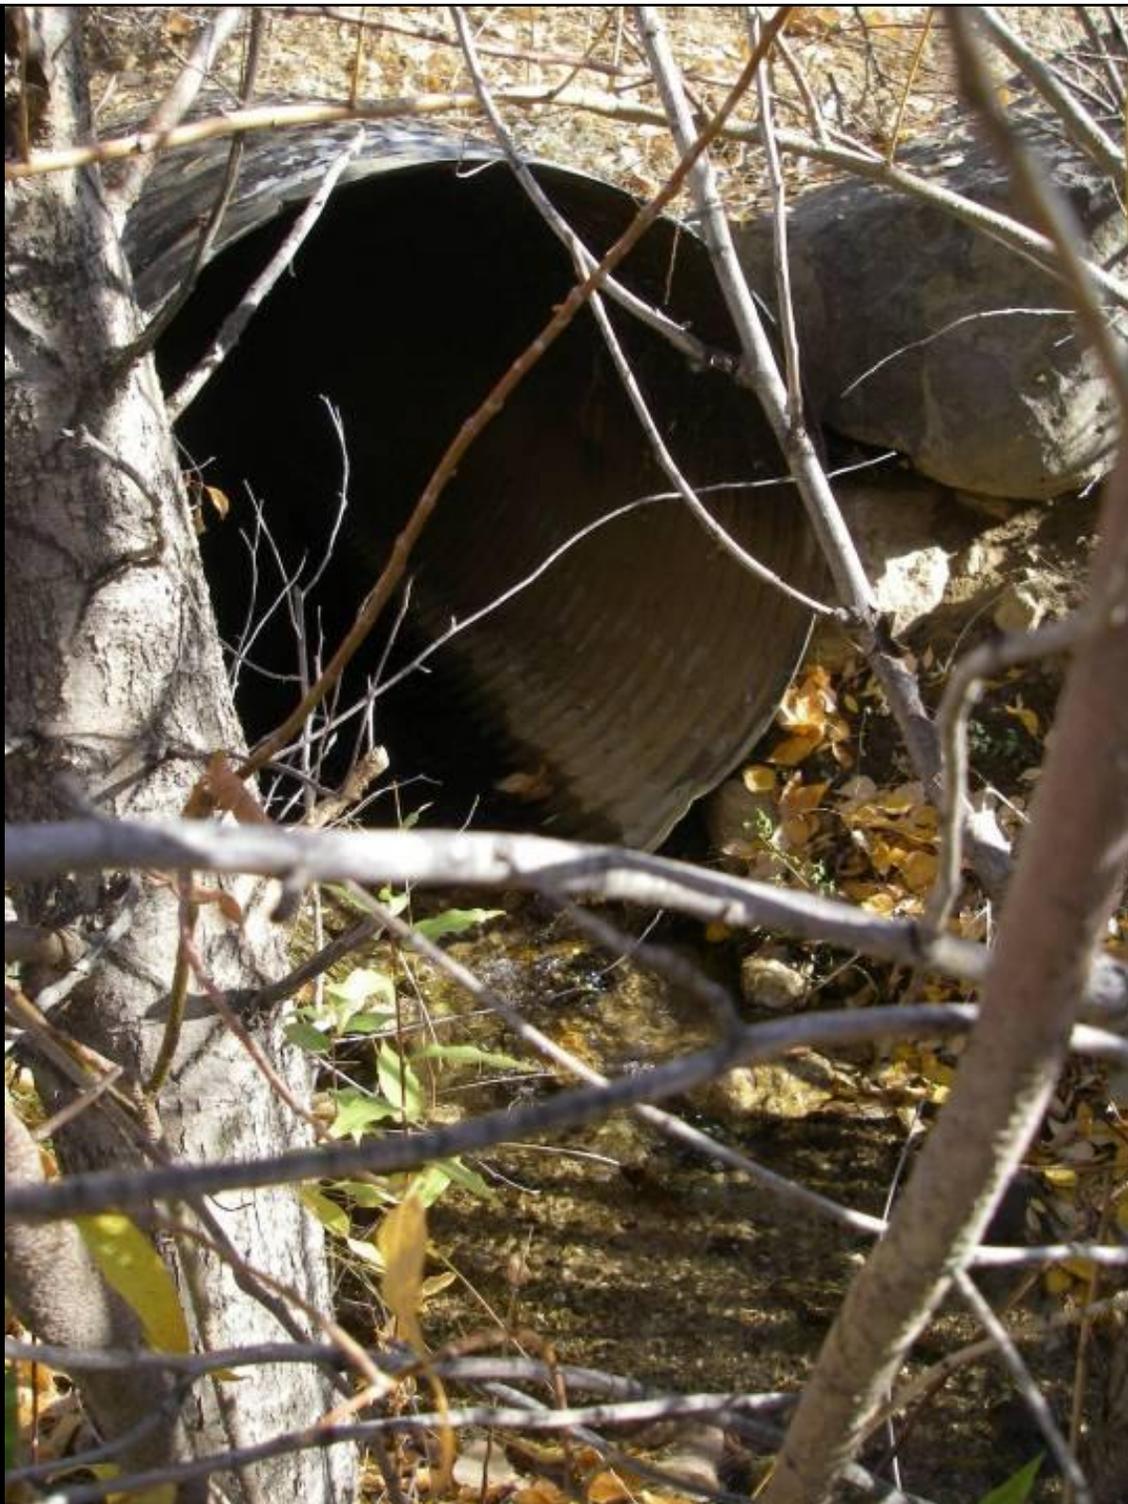
Pierce Creek upstream
of new Danskin access

Culvert shallows flow
extensively

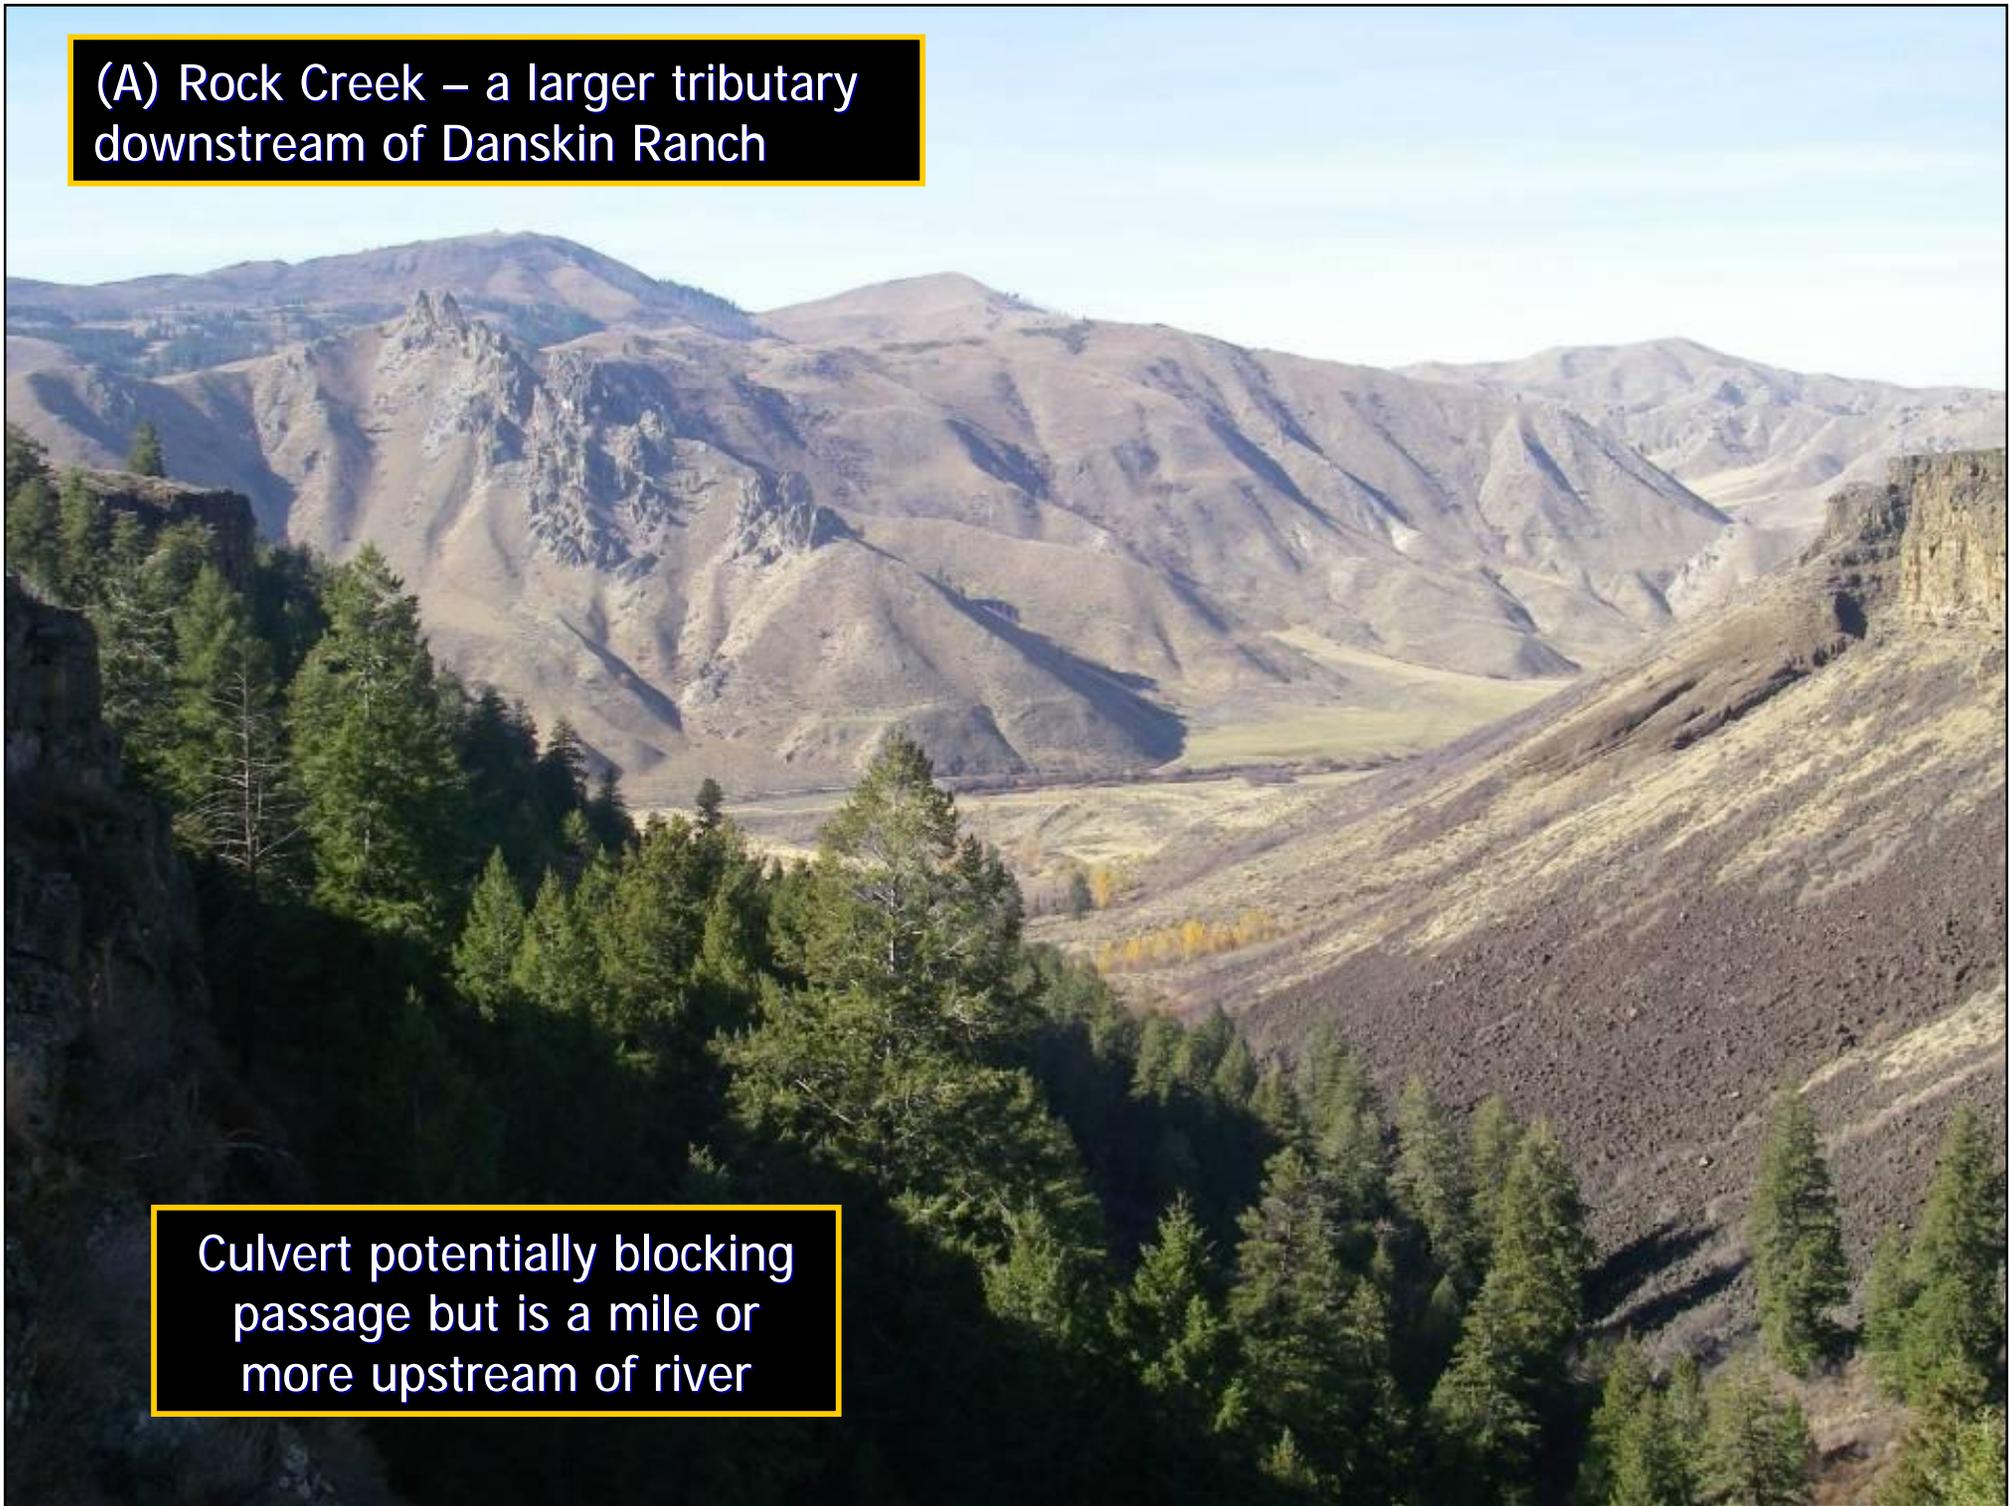
(A) Rock Creek – a larger tributary
downstream of Danskin Ranch

Culvert potentially blocking
passage but is a mile or
more upstream of river
