Potential Spawning
Tributaries
for

The South Fork Boise River

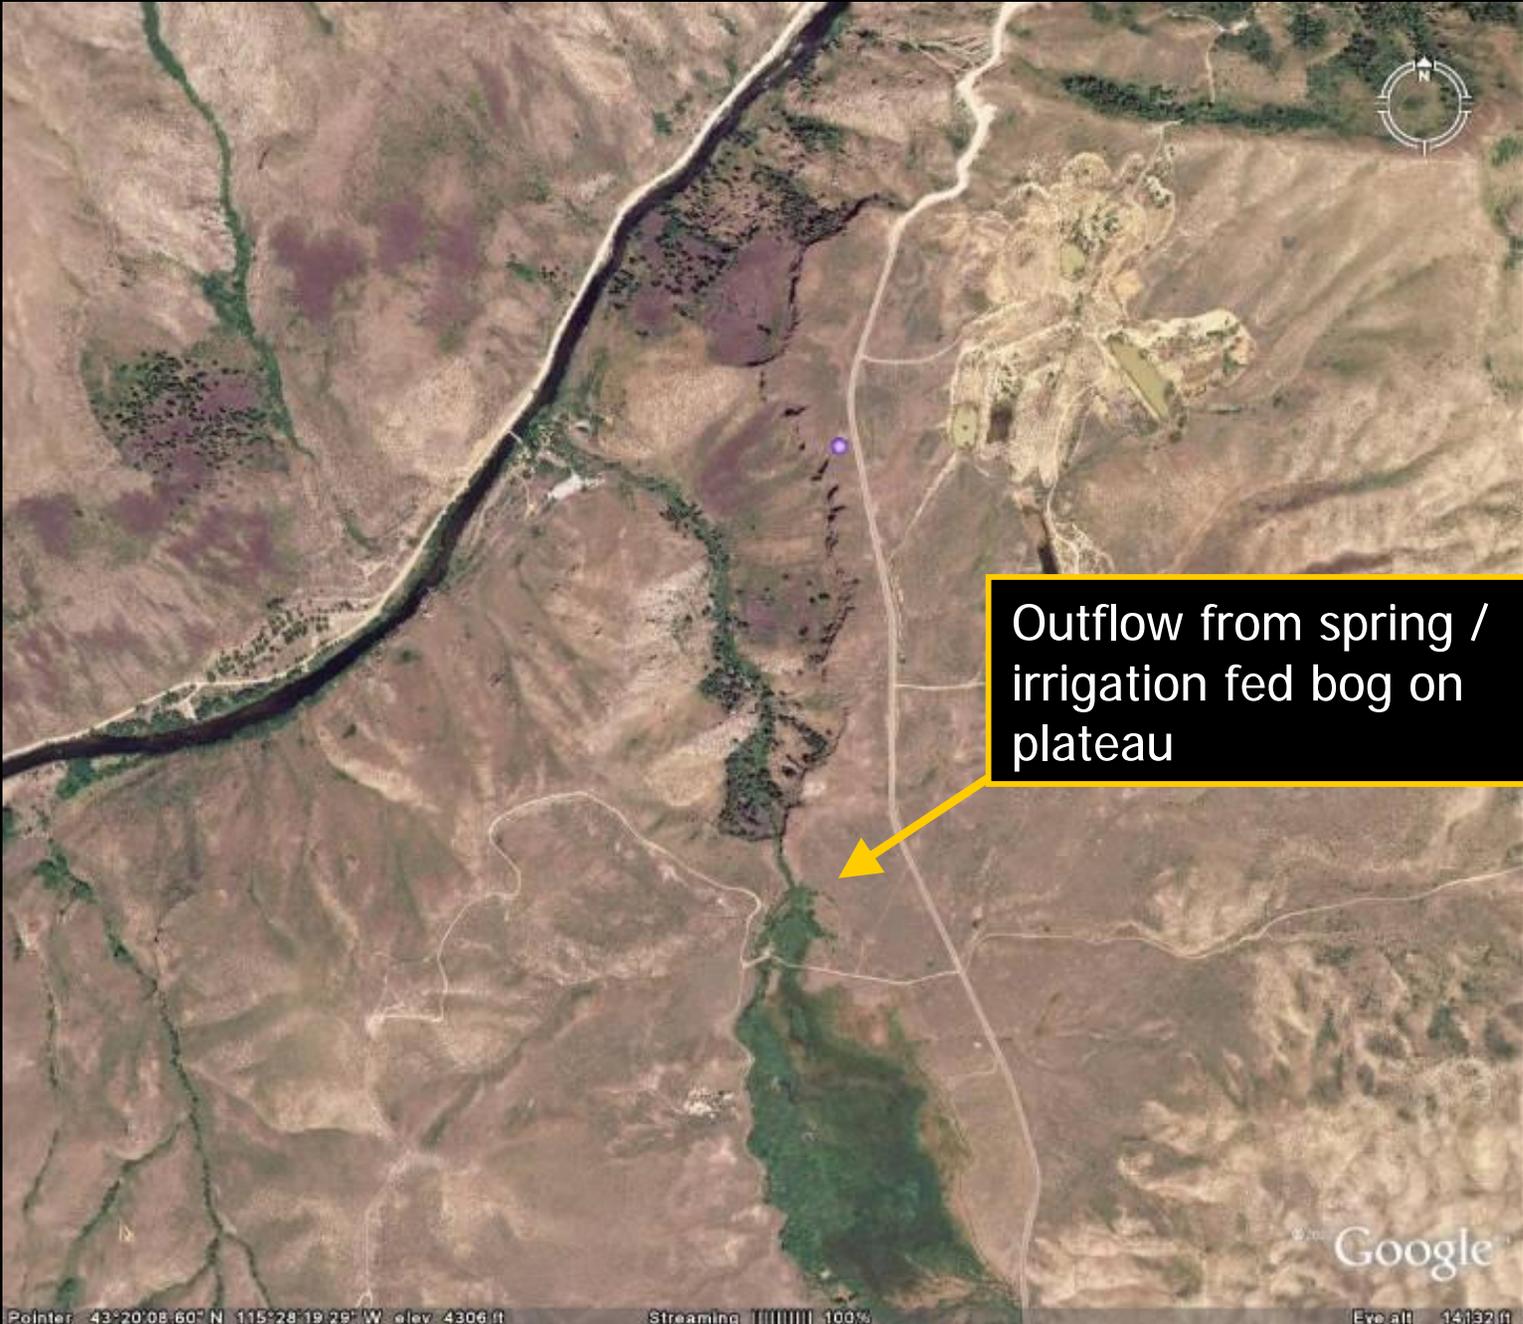
Dixie Creek at Anderson Ranch home

Outflow from spring /
irrigation fed bog on
plateau

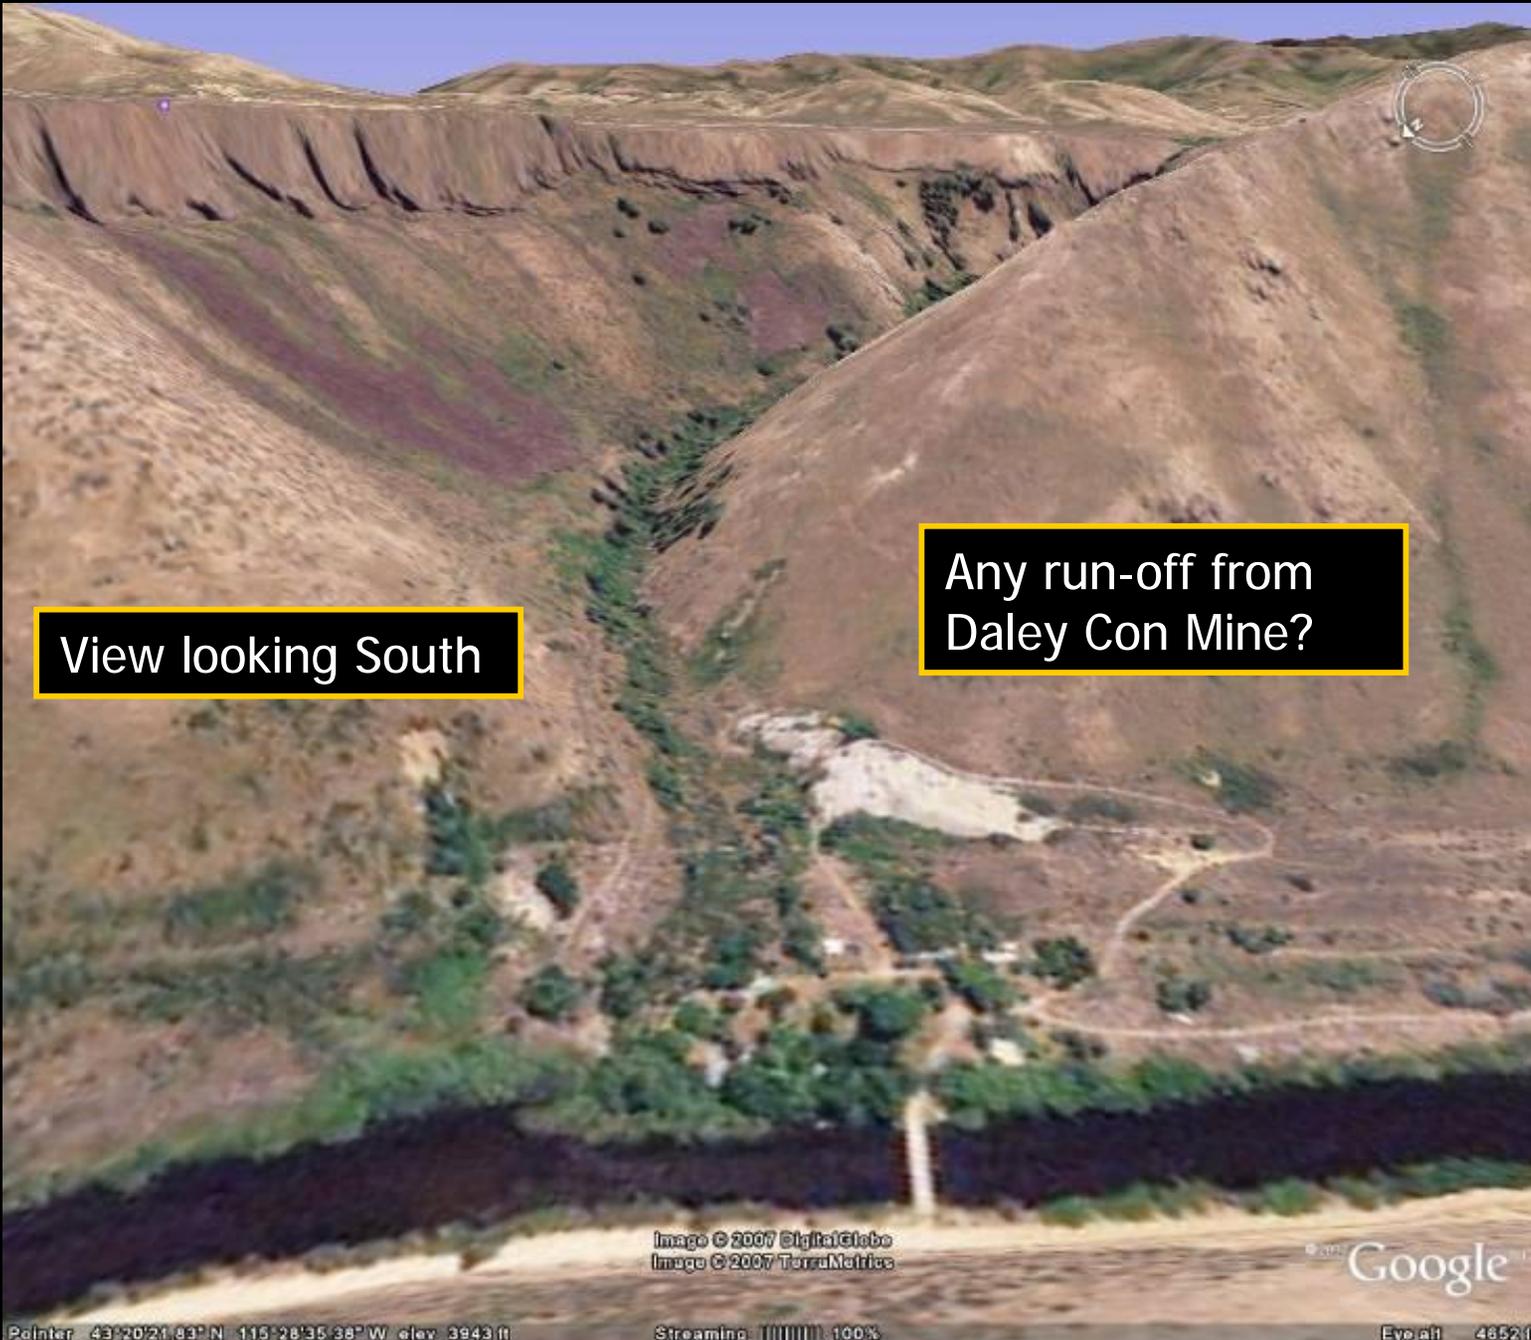
Dixie Creek at Anderson Ranch home

Any run-off from Daley Con Mine?

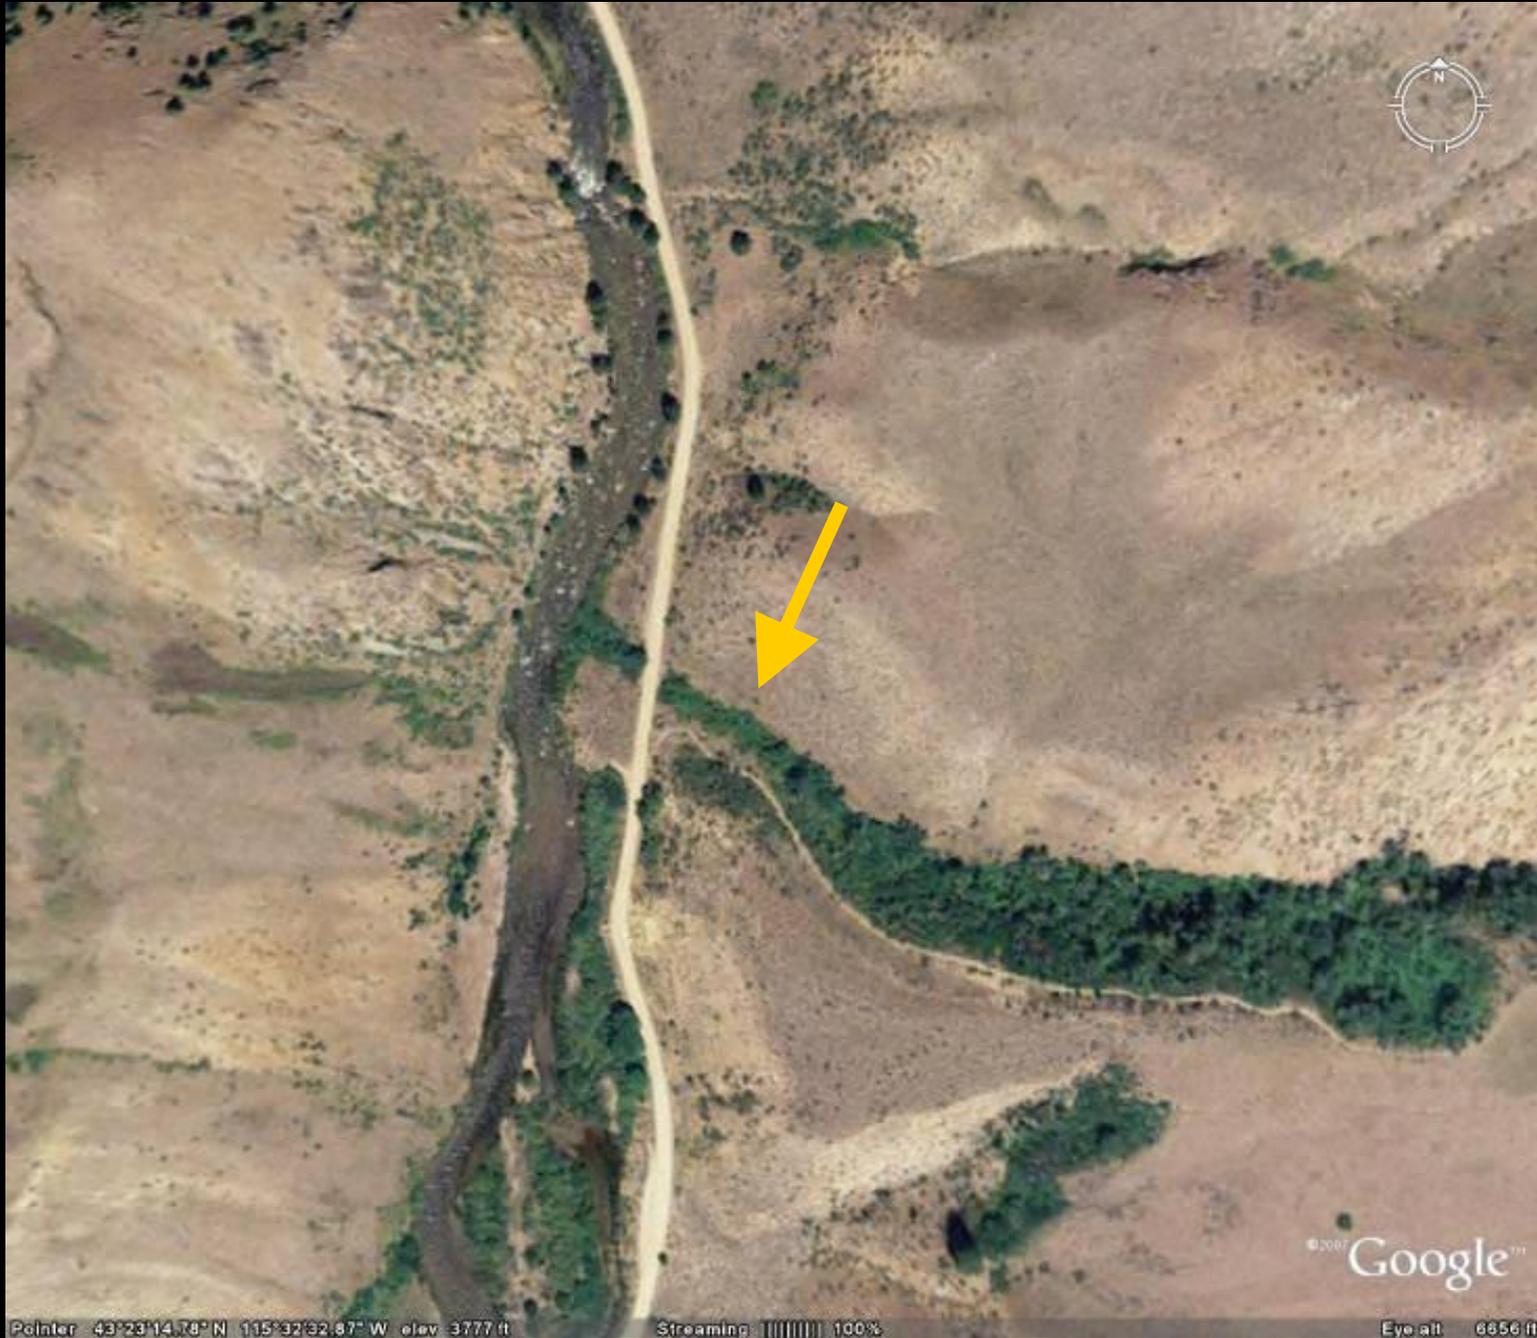
Granite Creek upstream of Pine Tree Rapid

Most promising habitat for rehabilitation but significant work needed – culvert, mouth, obstructions

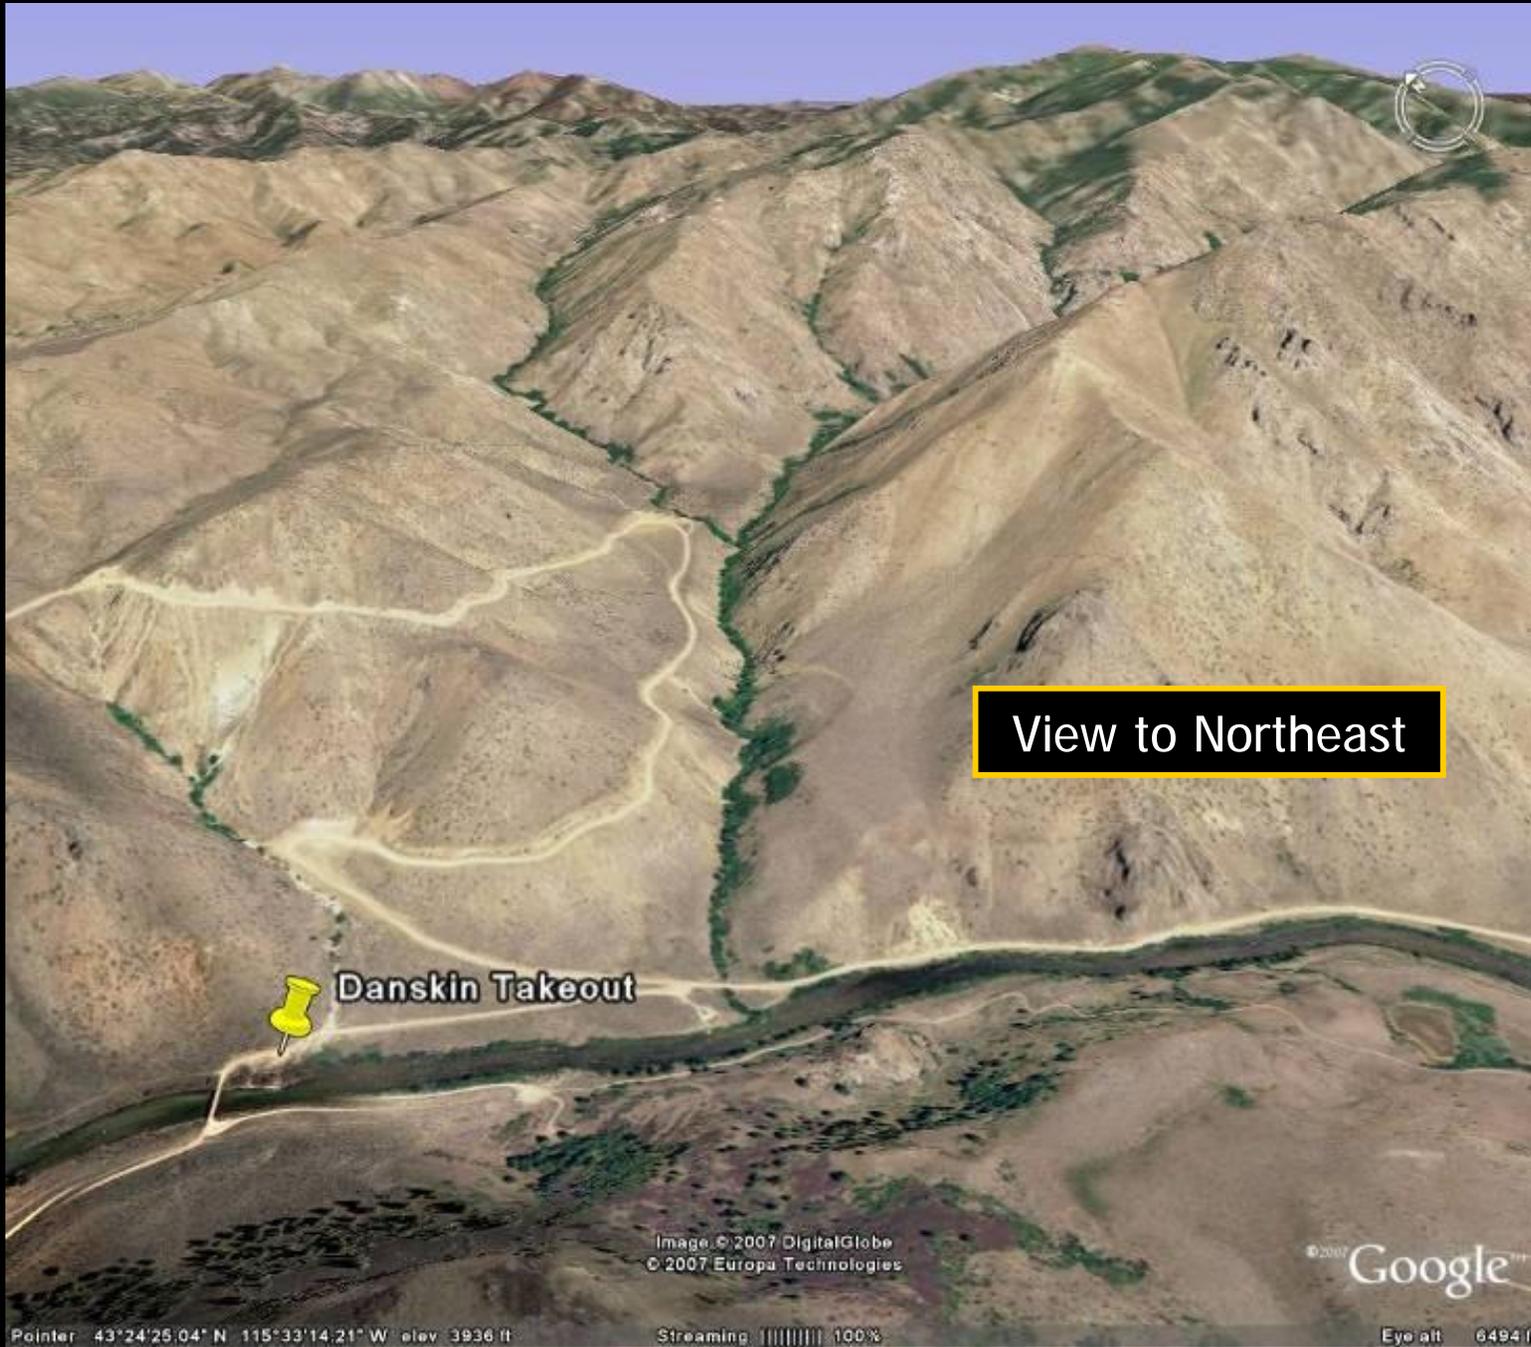
Pierce Creek upstream
of Danskin Ramp

Upstream of Culvert –
good spawning gravel

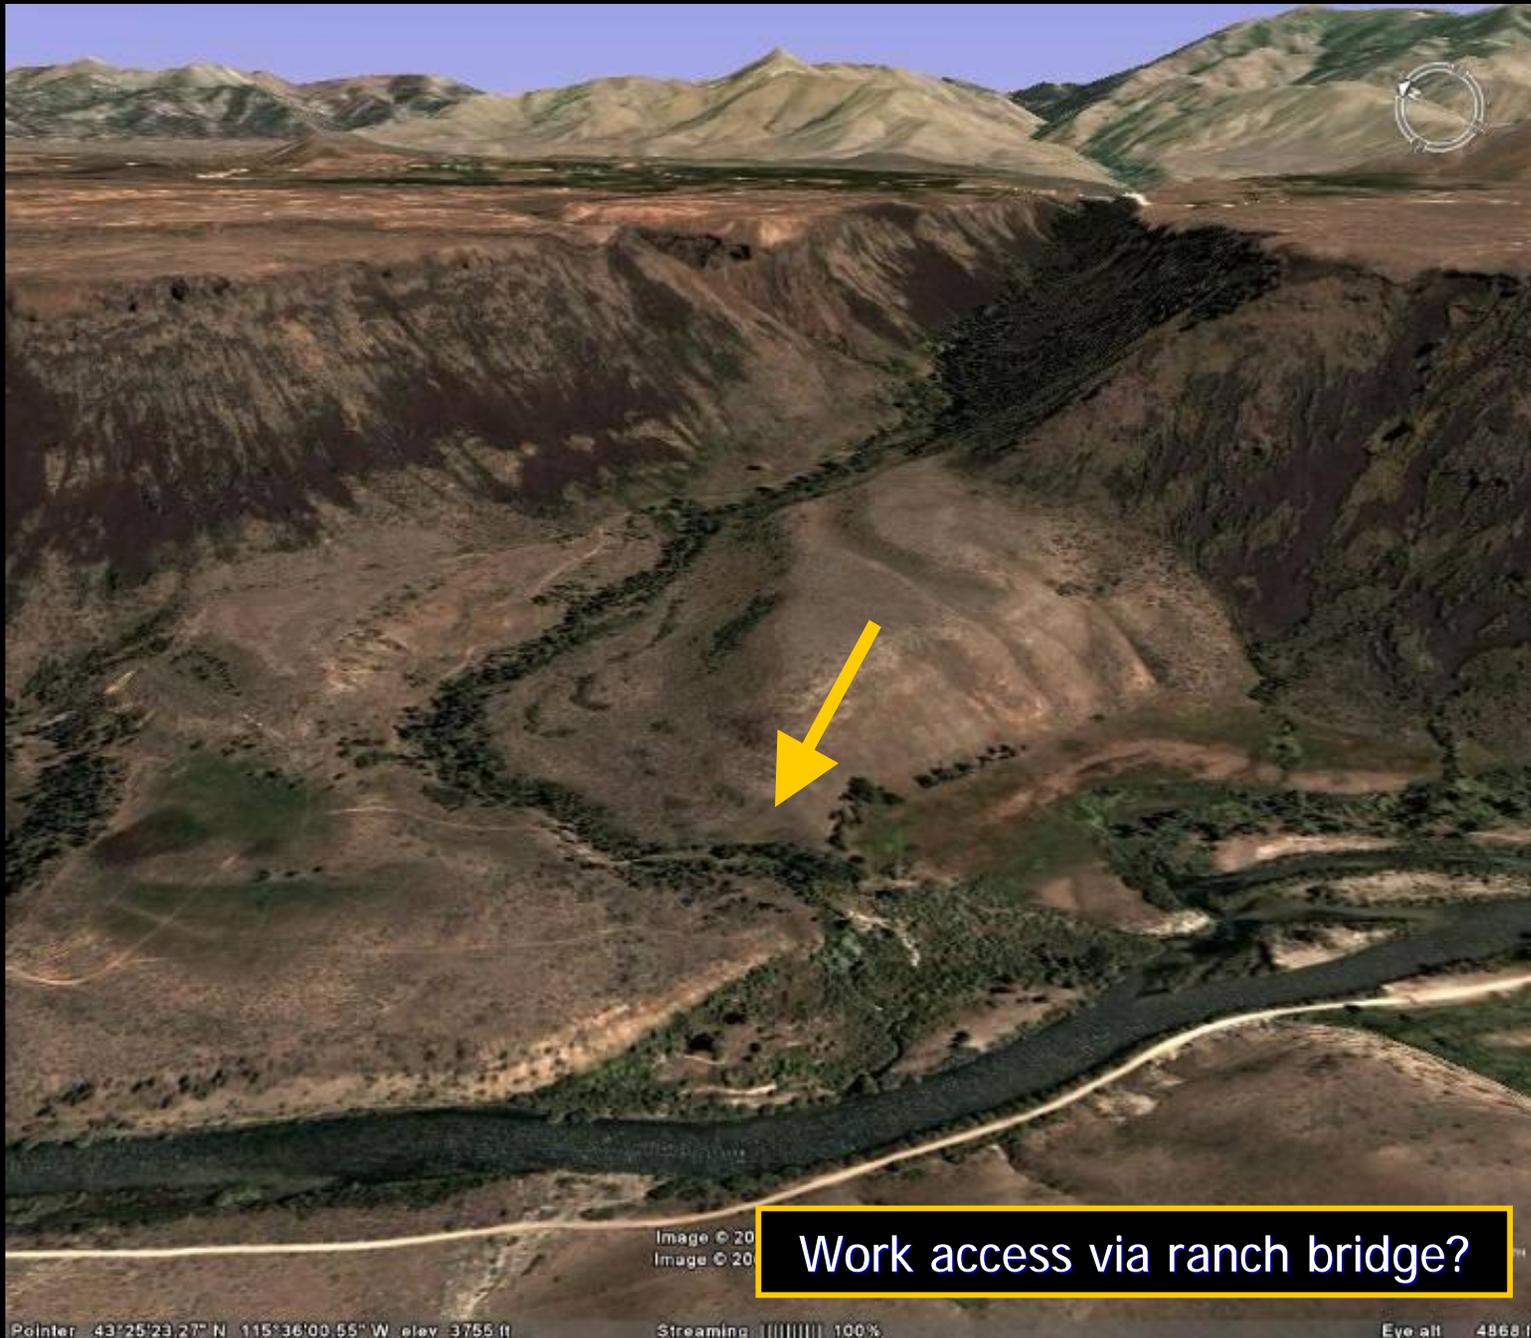
(A) Rock Creek – a larger tributary
downstream of Danskin Ranch

Culvert potentially blocking
passage but is a mile or
more upstream of river

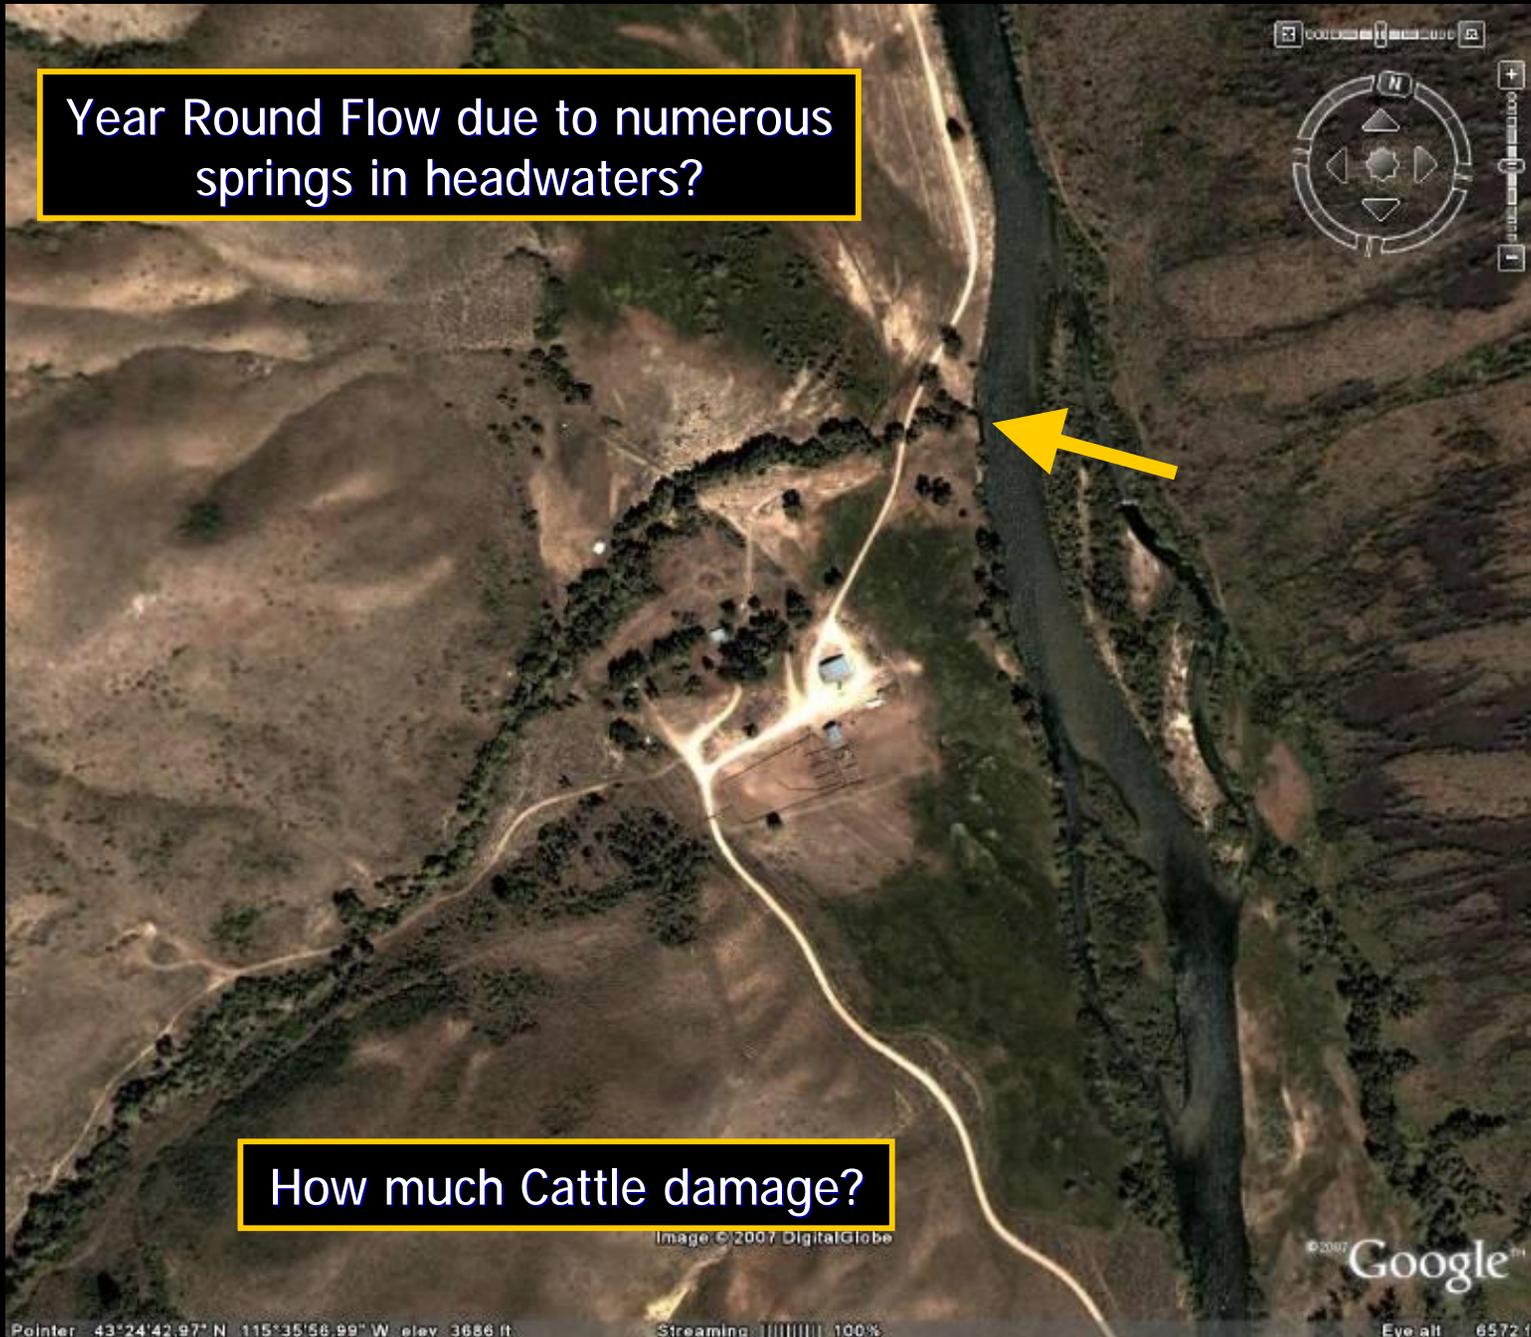
(B) Bock Creek at Ranch downstream of Danskin

Year Round Flow due to numerous springs in headwaters?

How much Cattle damage?
